WS 107A-1 WEAPON SYSTEM

SILO FULL-SCALE MOCKUP

PHOTOGRAPH RECORD

15 May 1961

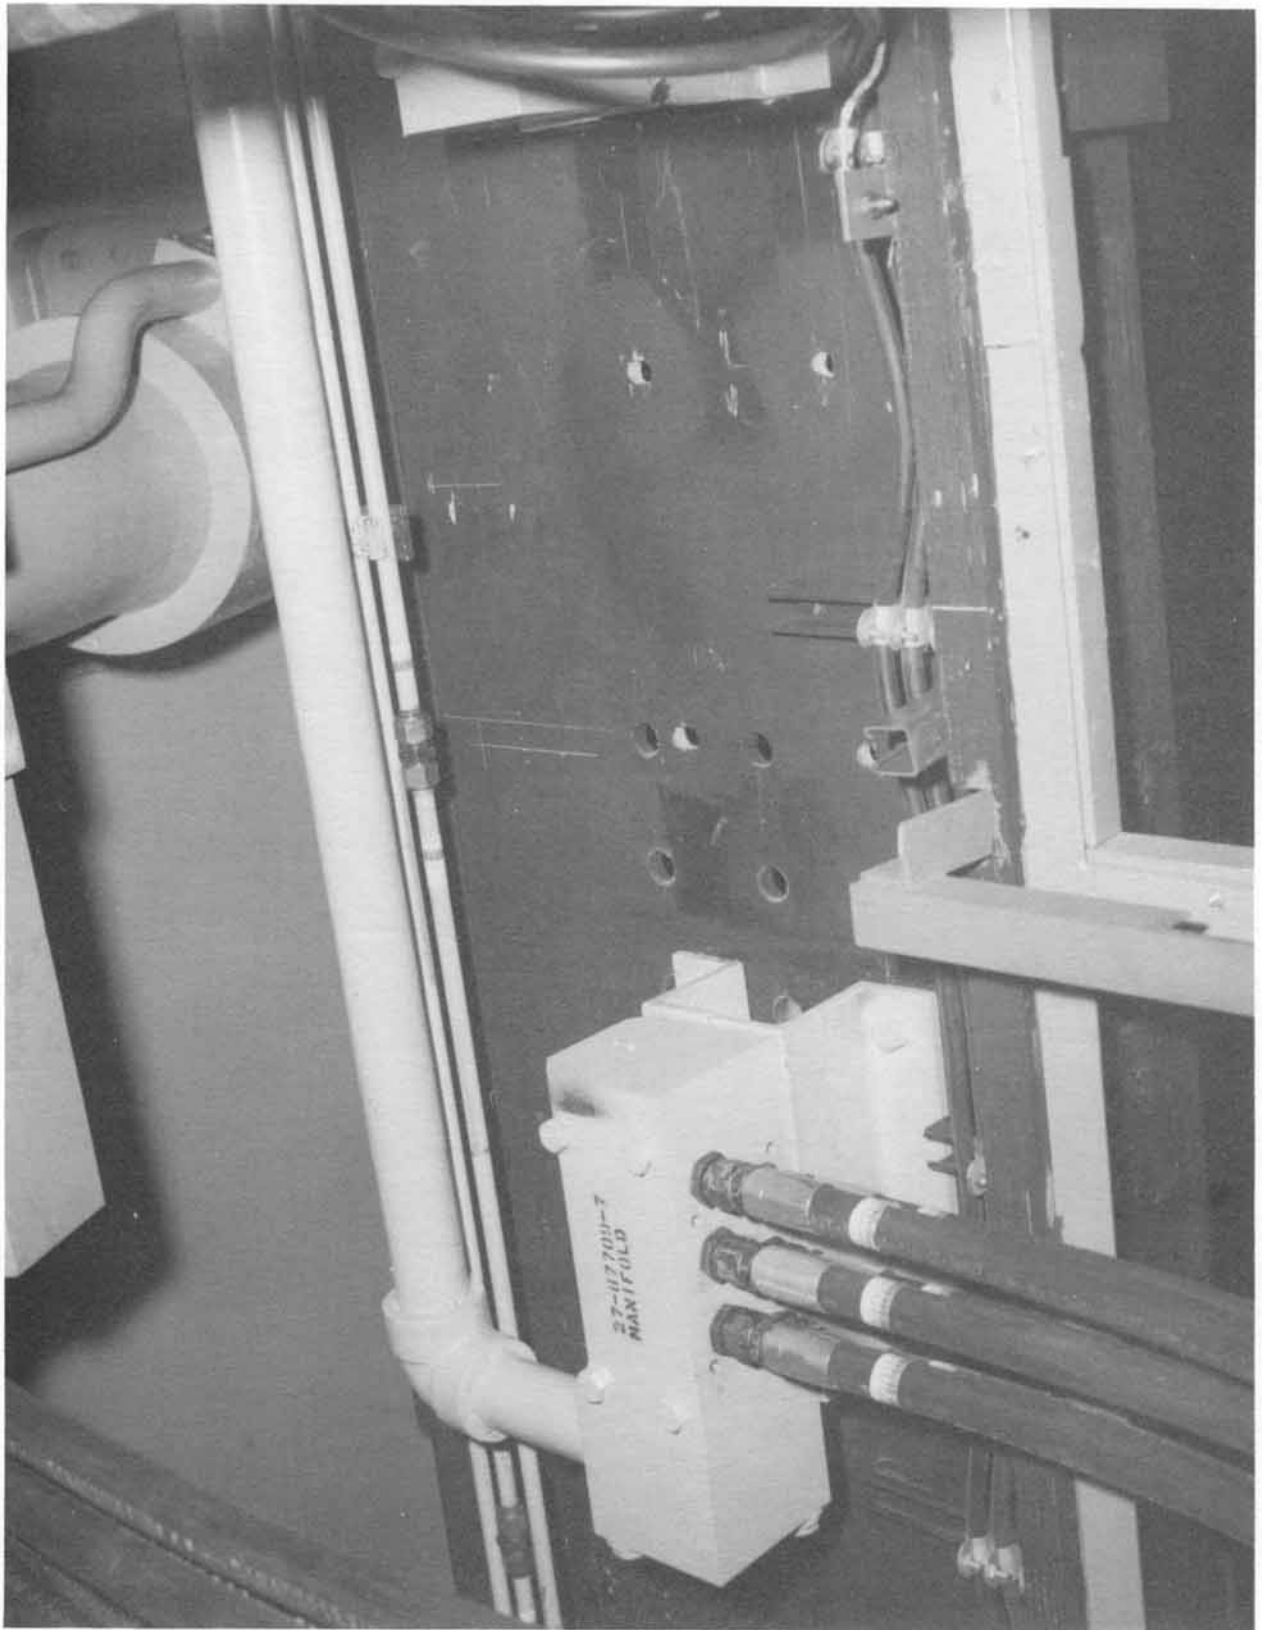
Hydraulic tubes above Column J (Neg. No. 66241A dated 3-23-61)

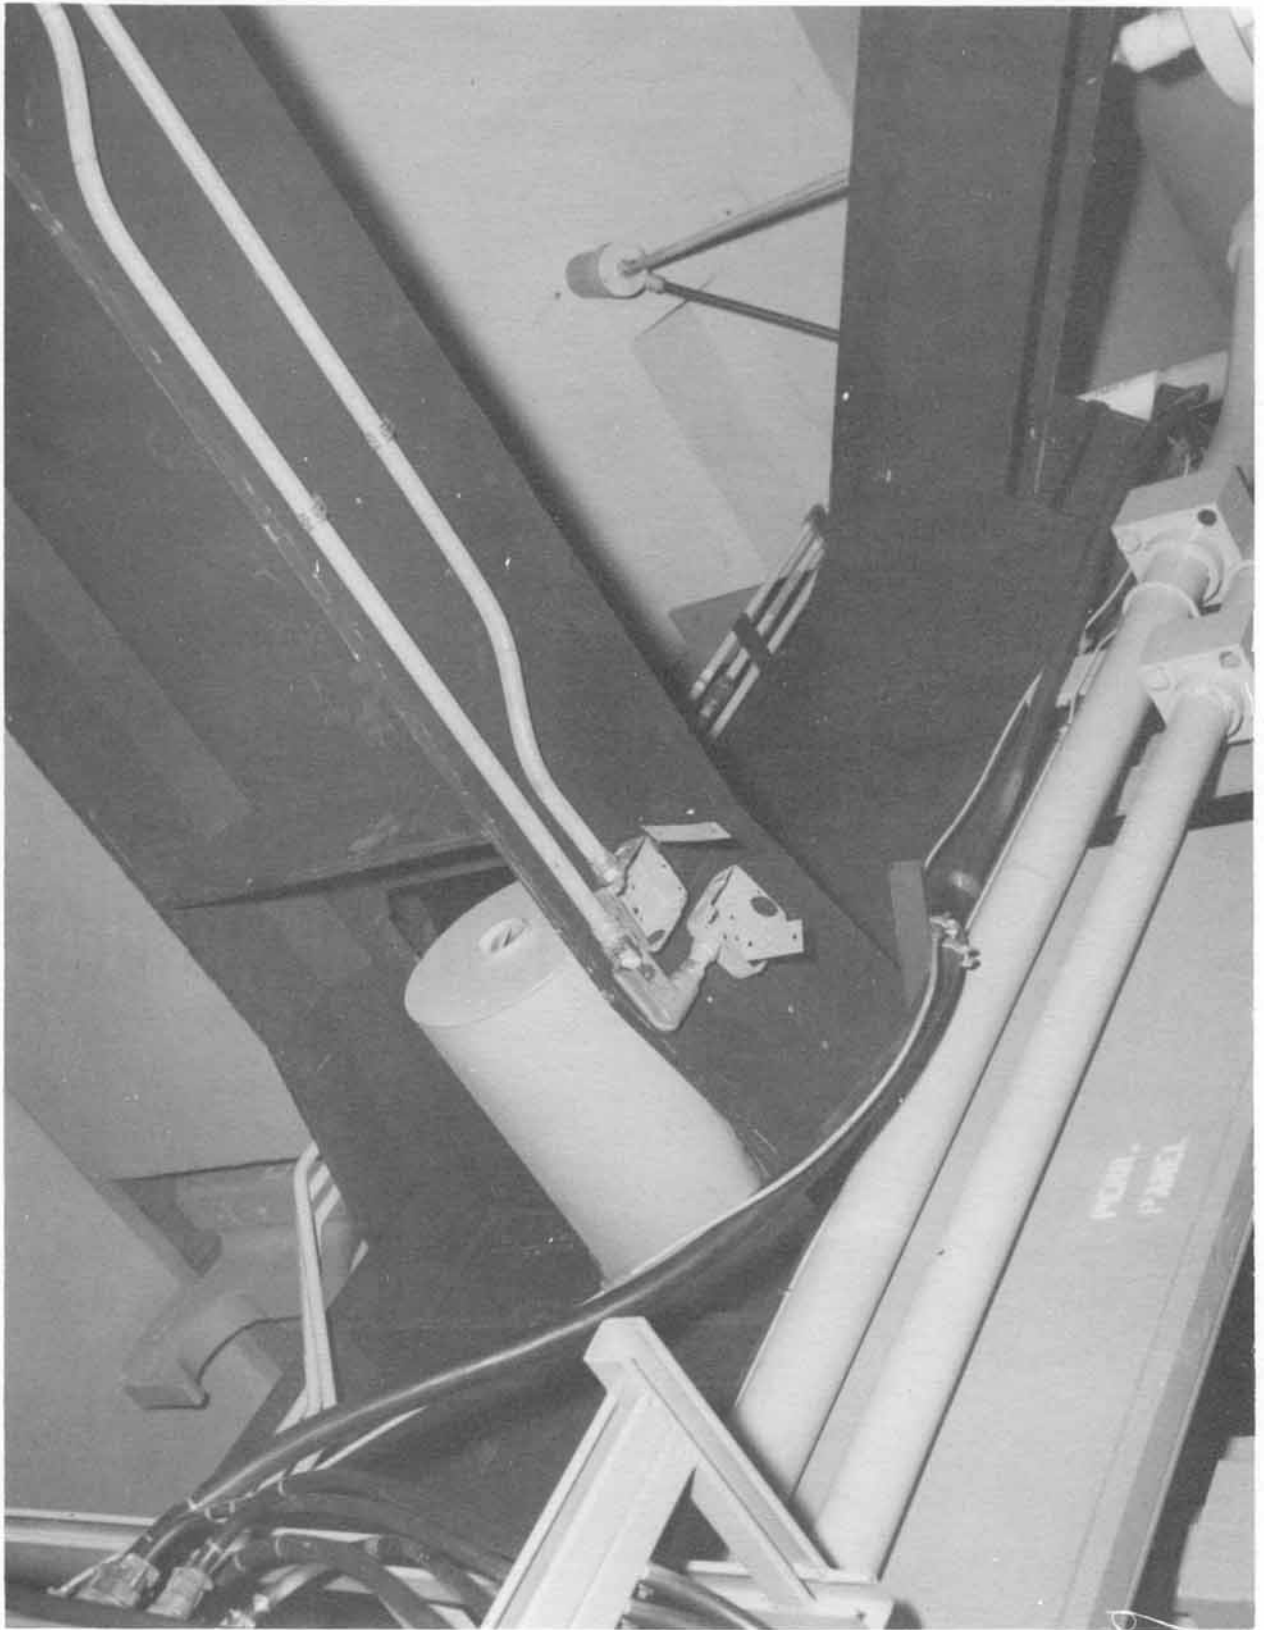
Hydraulic door manifolds, west side (Neg. No. 66245A dated 3-23-61).

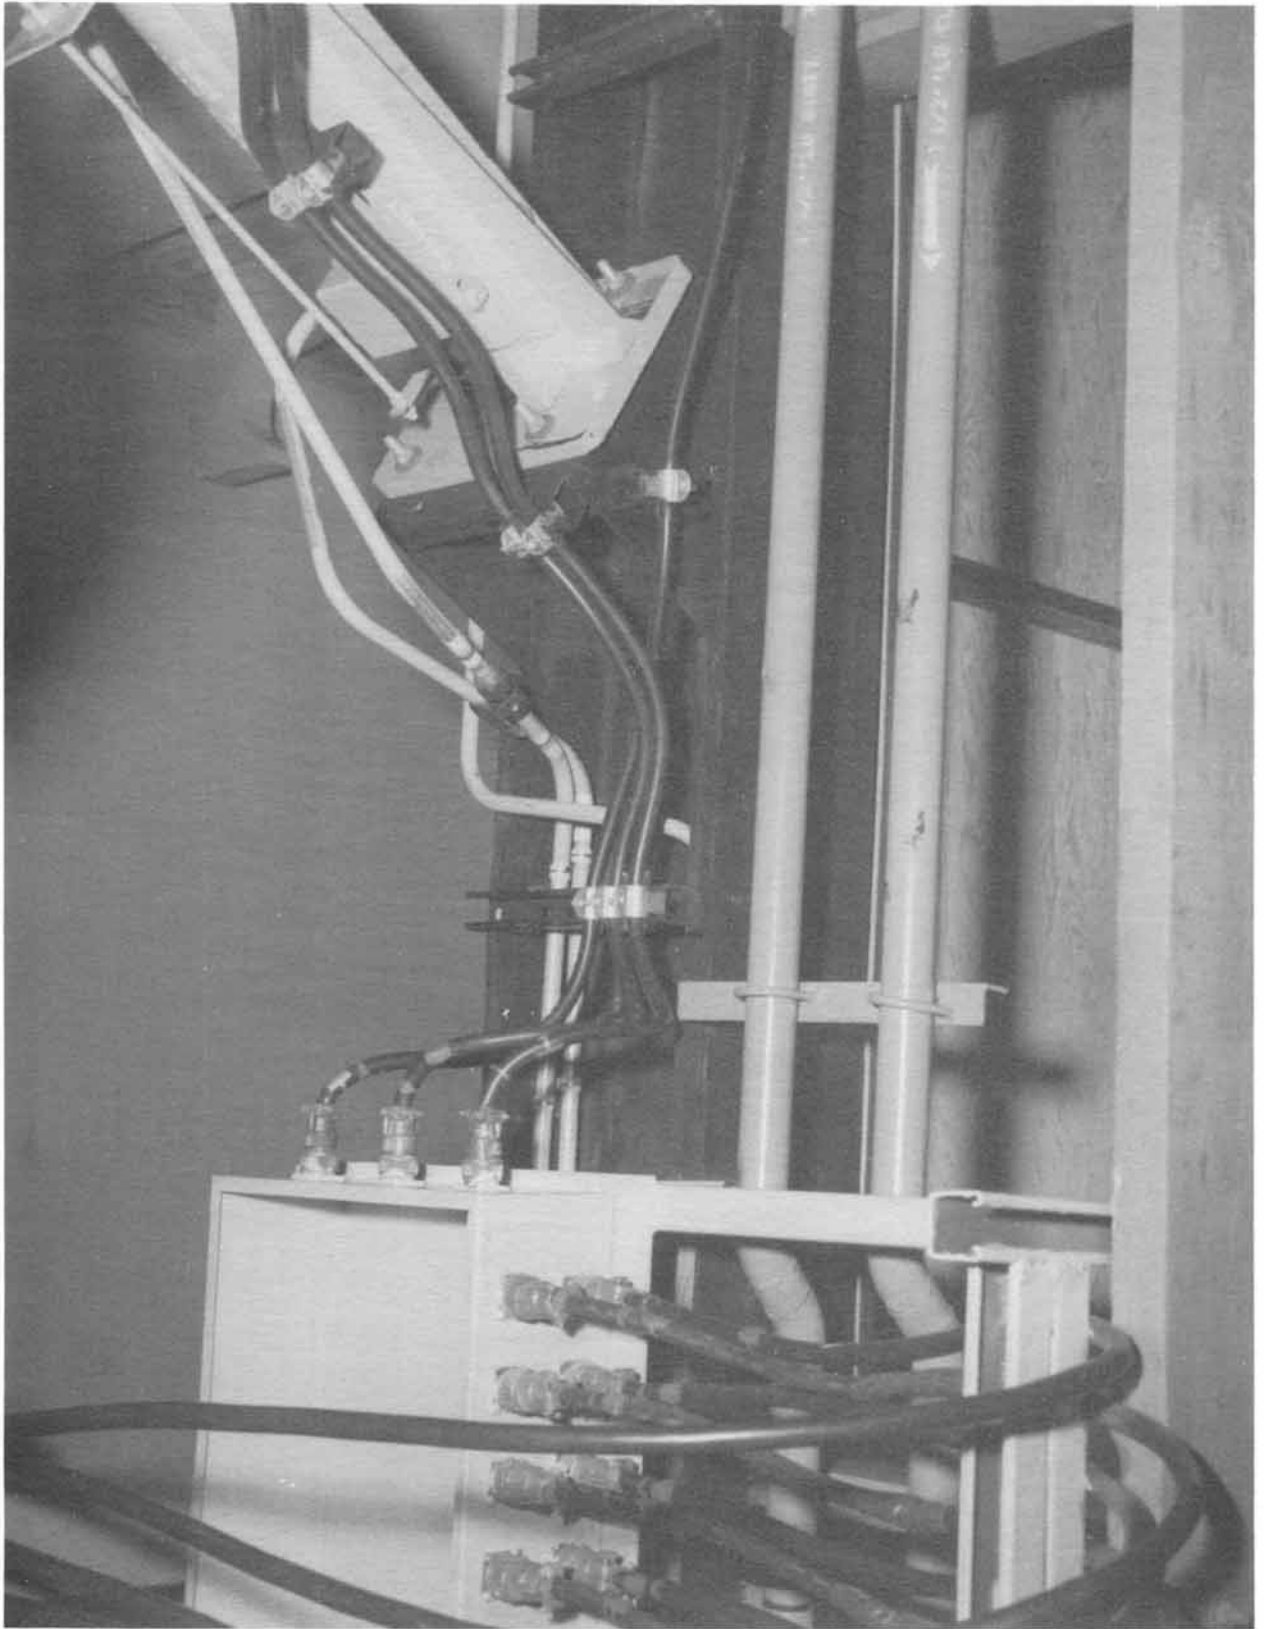
Horizontal crib lock at Column A (Neg. No. 66253A dated 3-23-61).

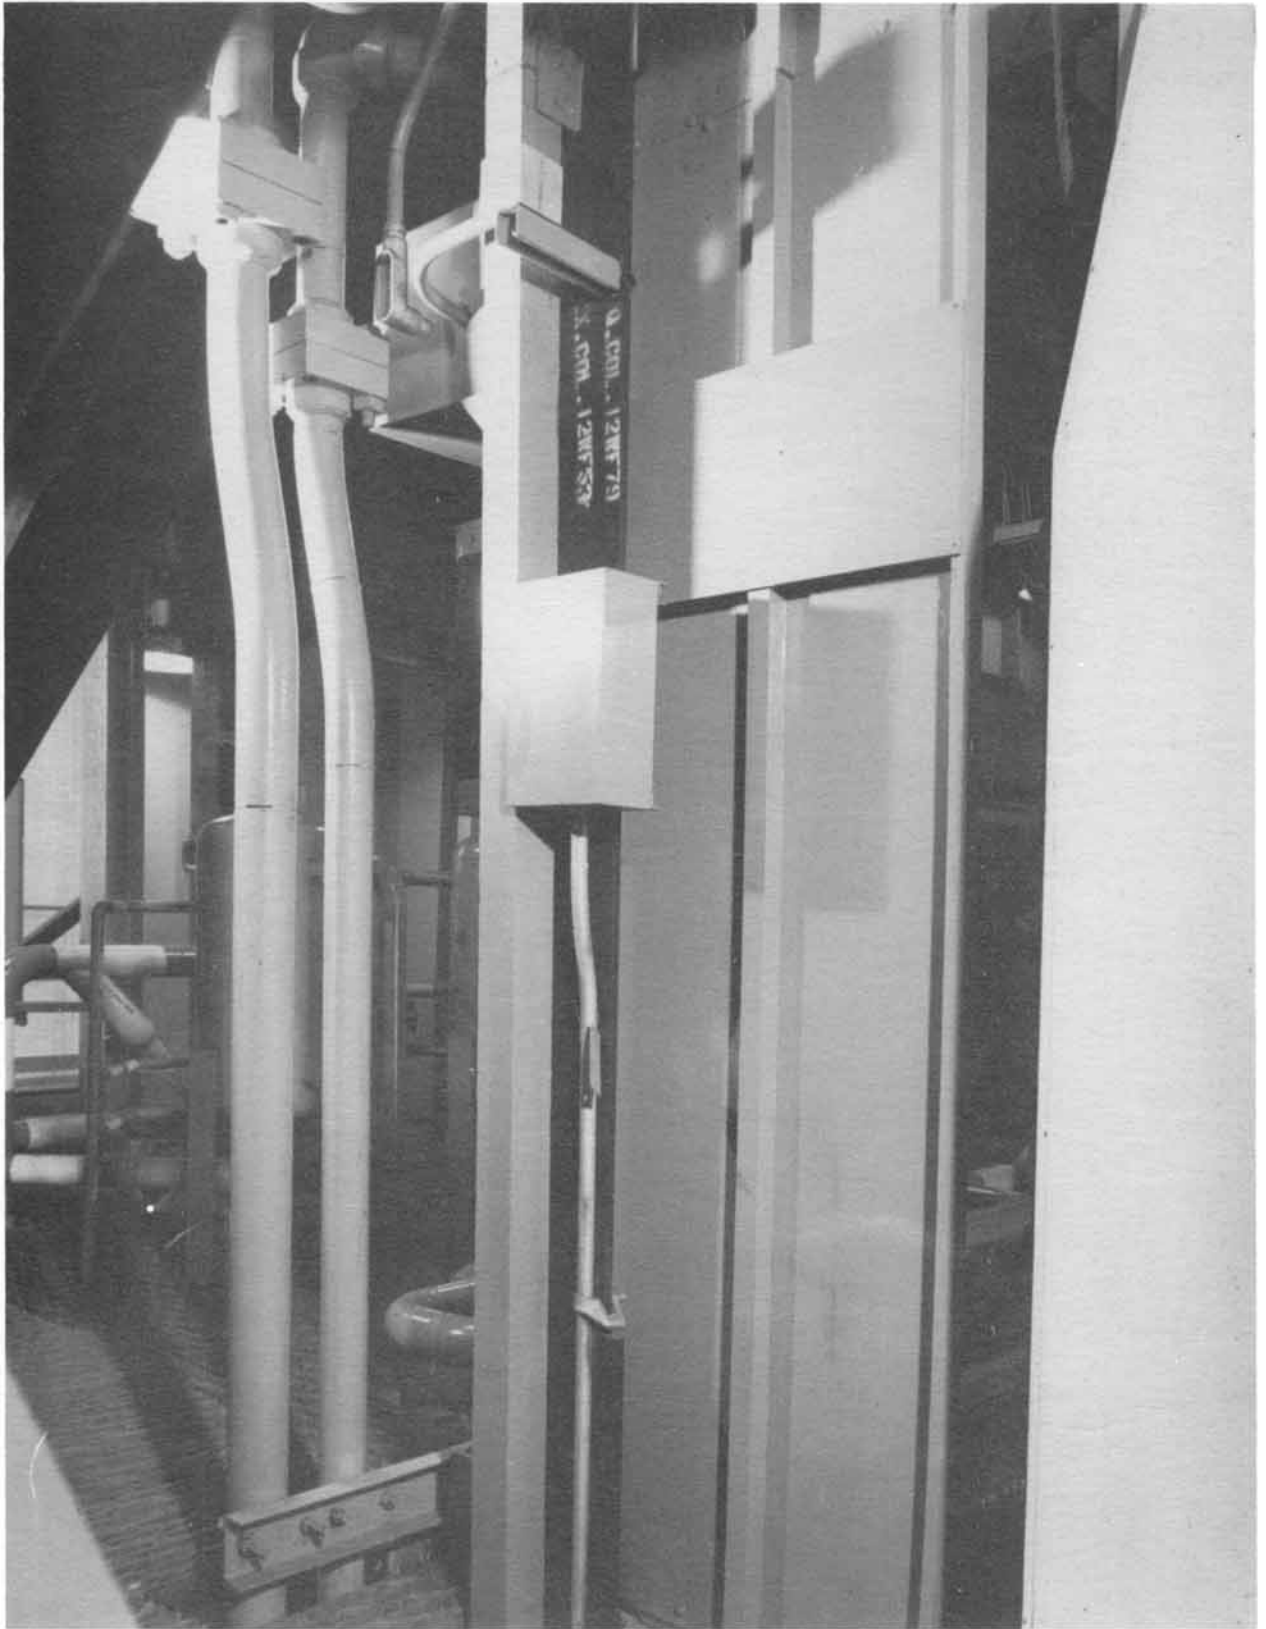
Hydraulic pipes at Column K from west (Neg. No. 66656A dated 4-3-61).

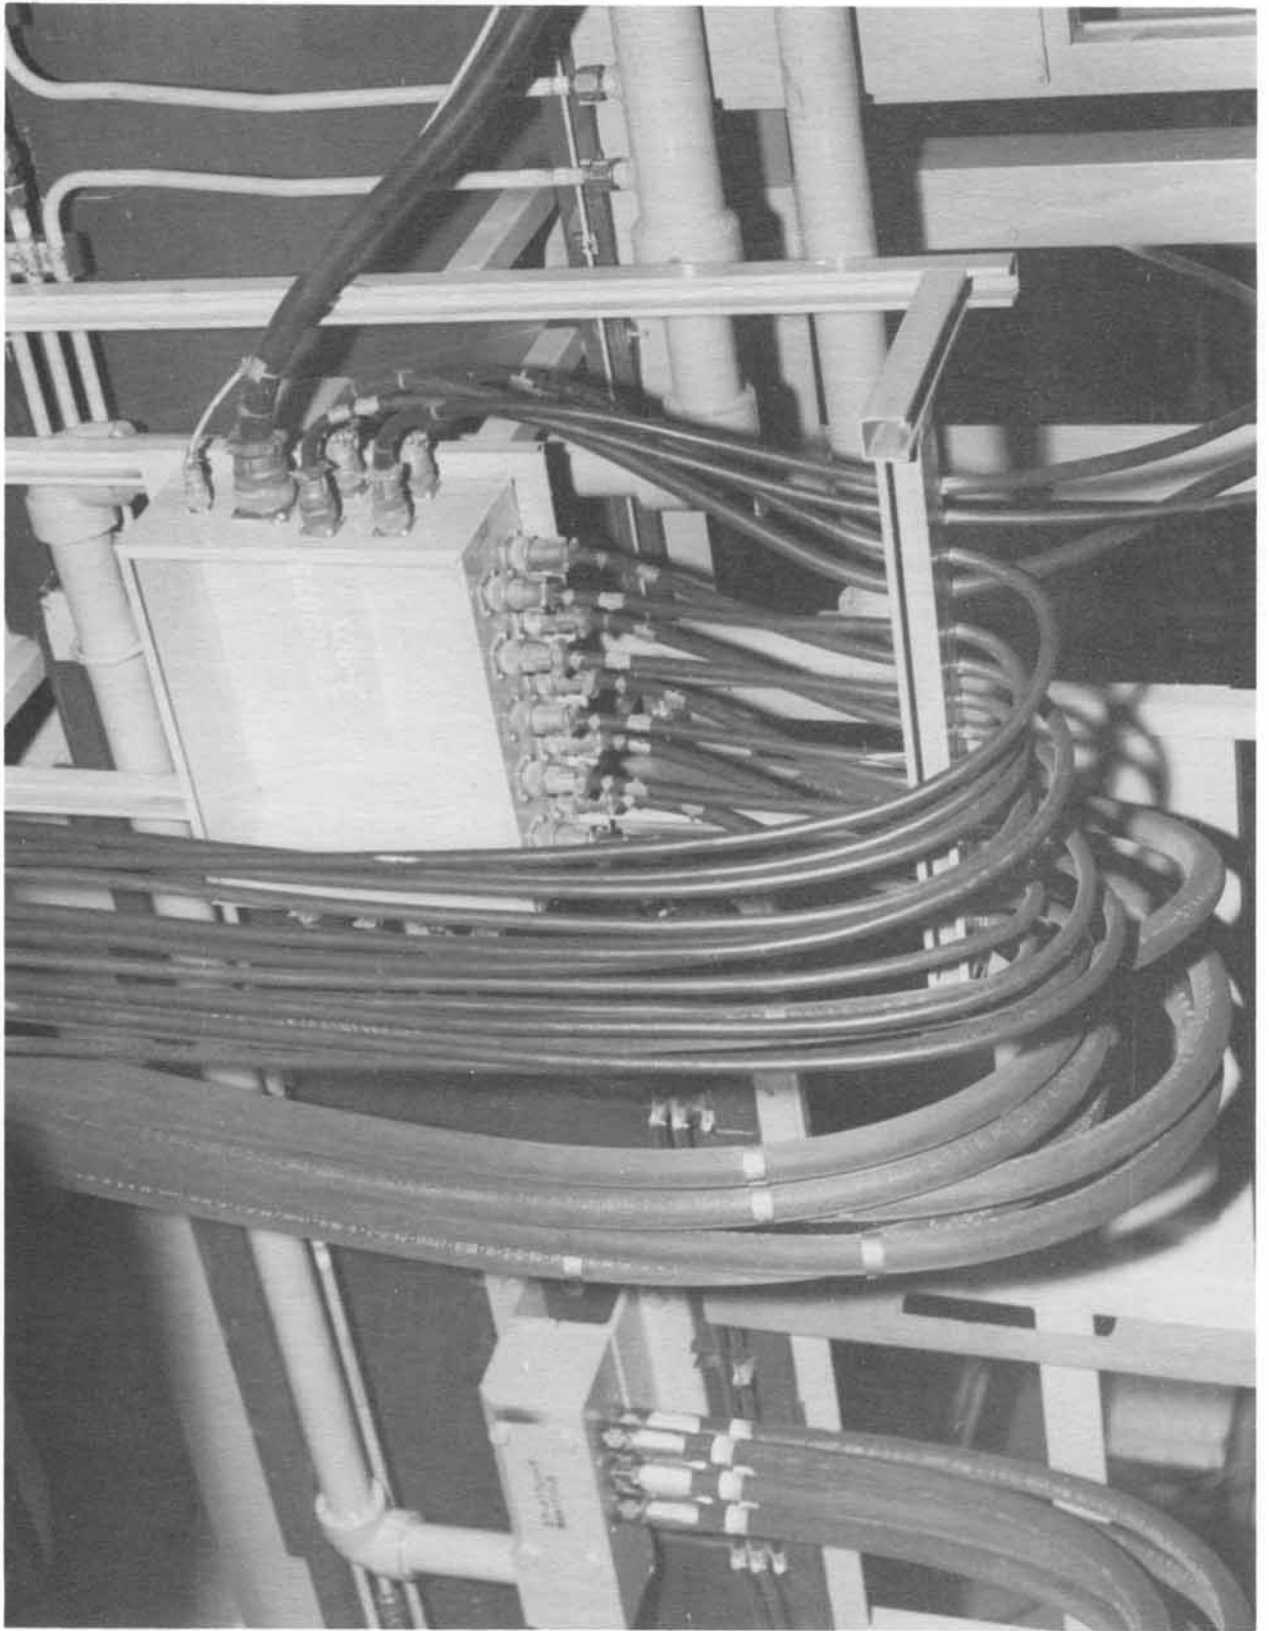
AMF J Box 27-09953 (Neg. No. 67320A dated 4-14-61).

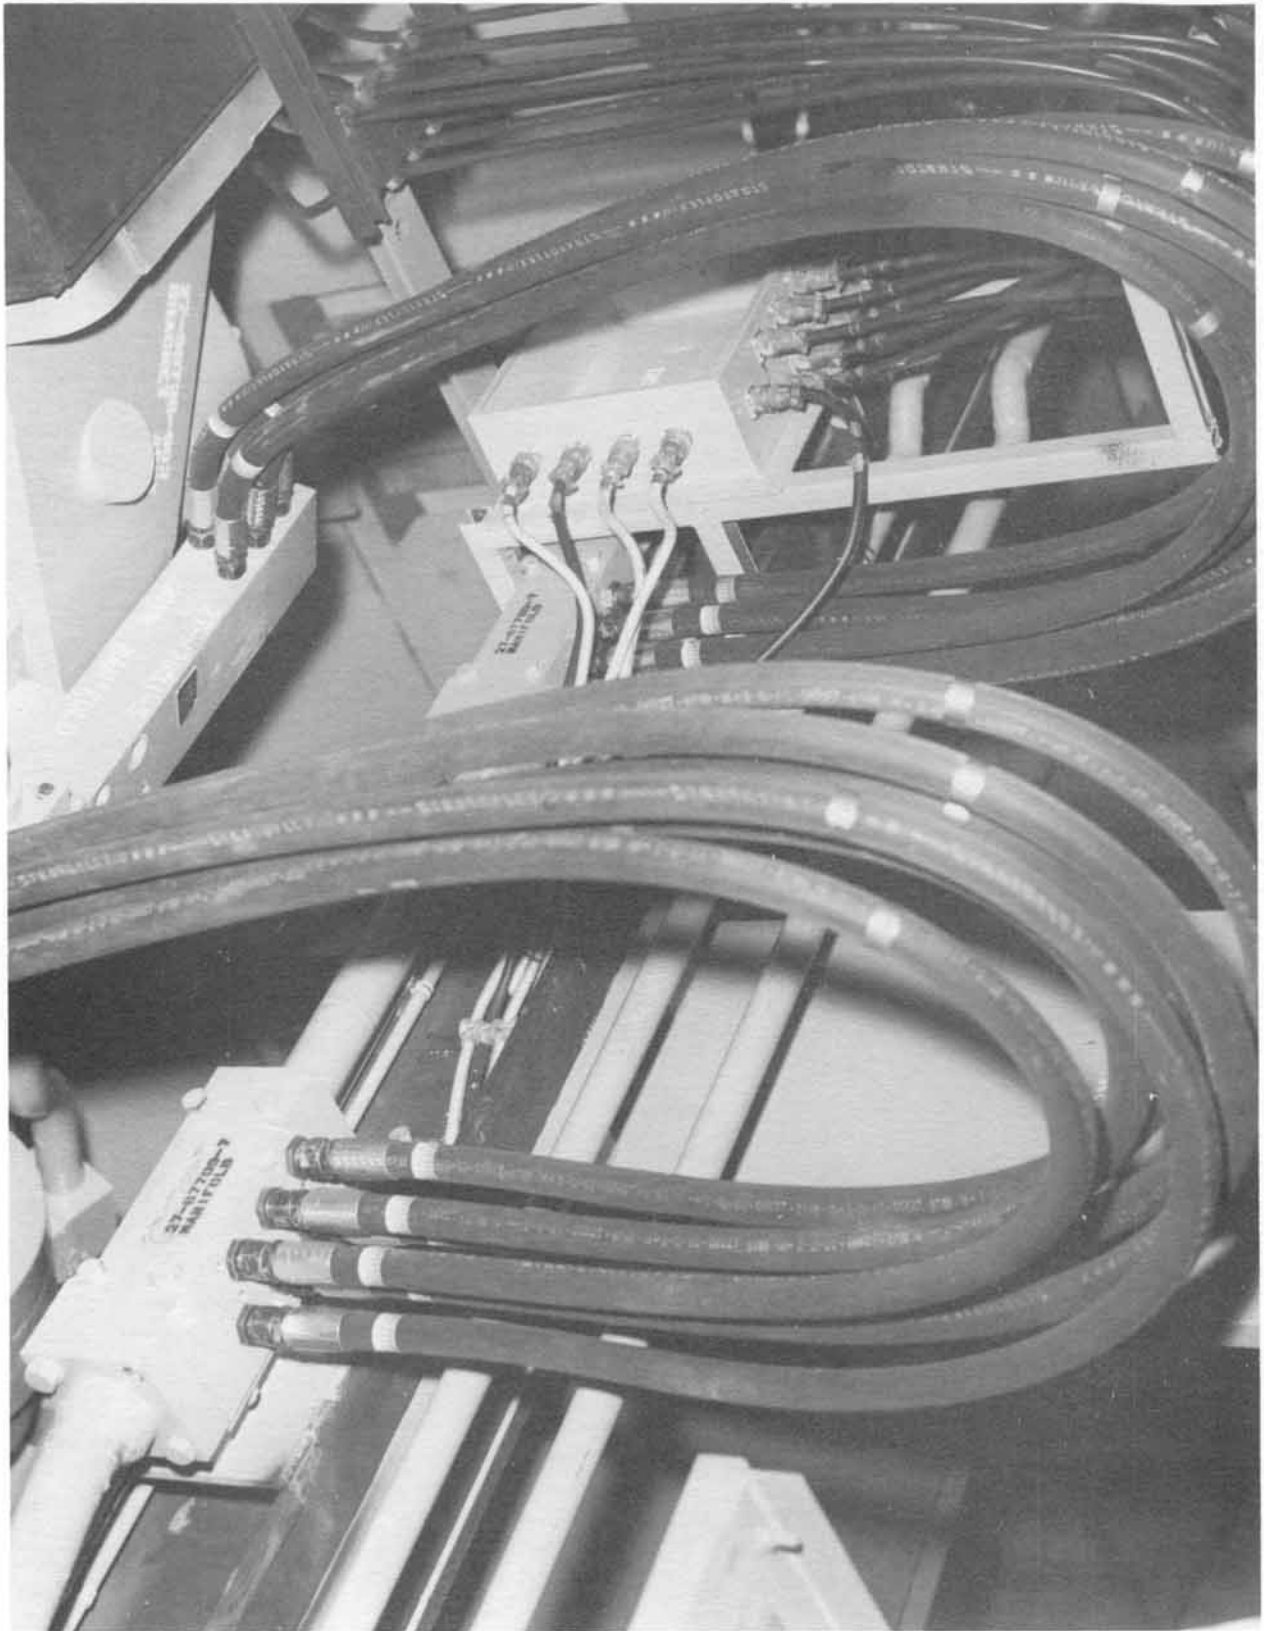
Column K hydraulic piping looking southeast (Neg. No. 67322A dated 4-14-61).

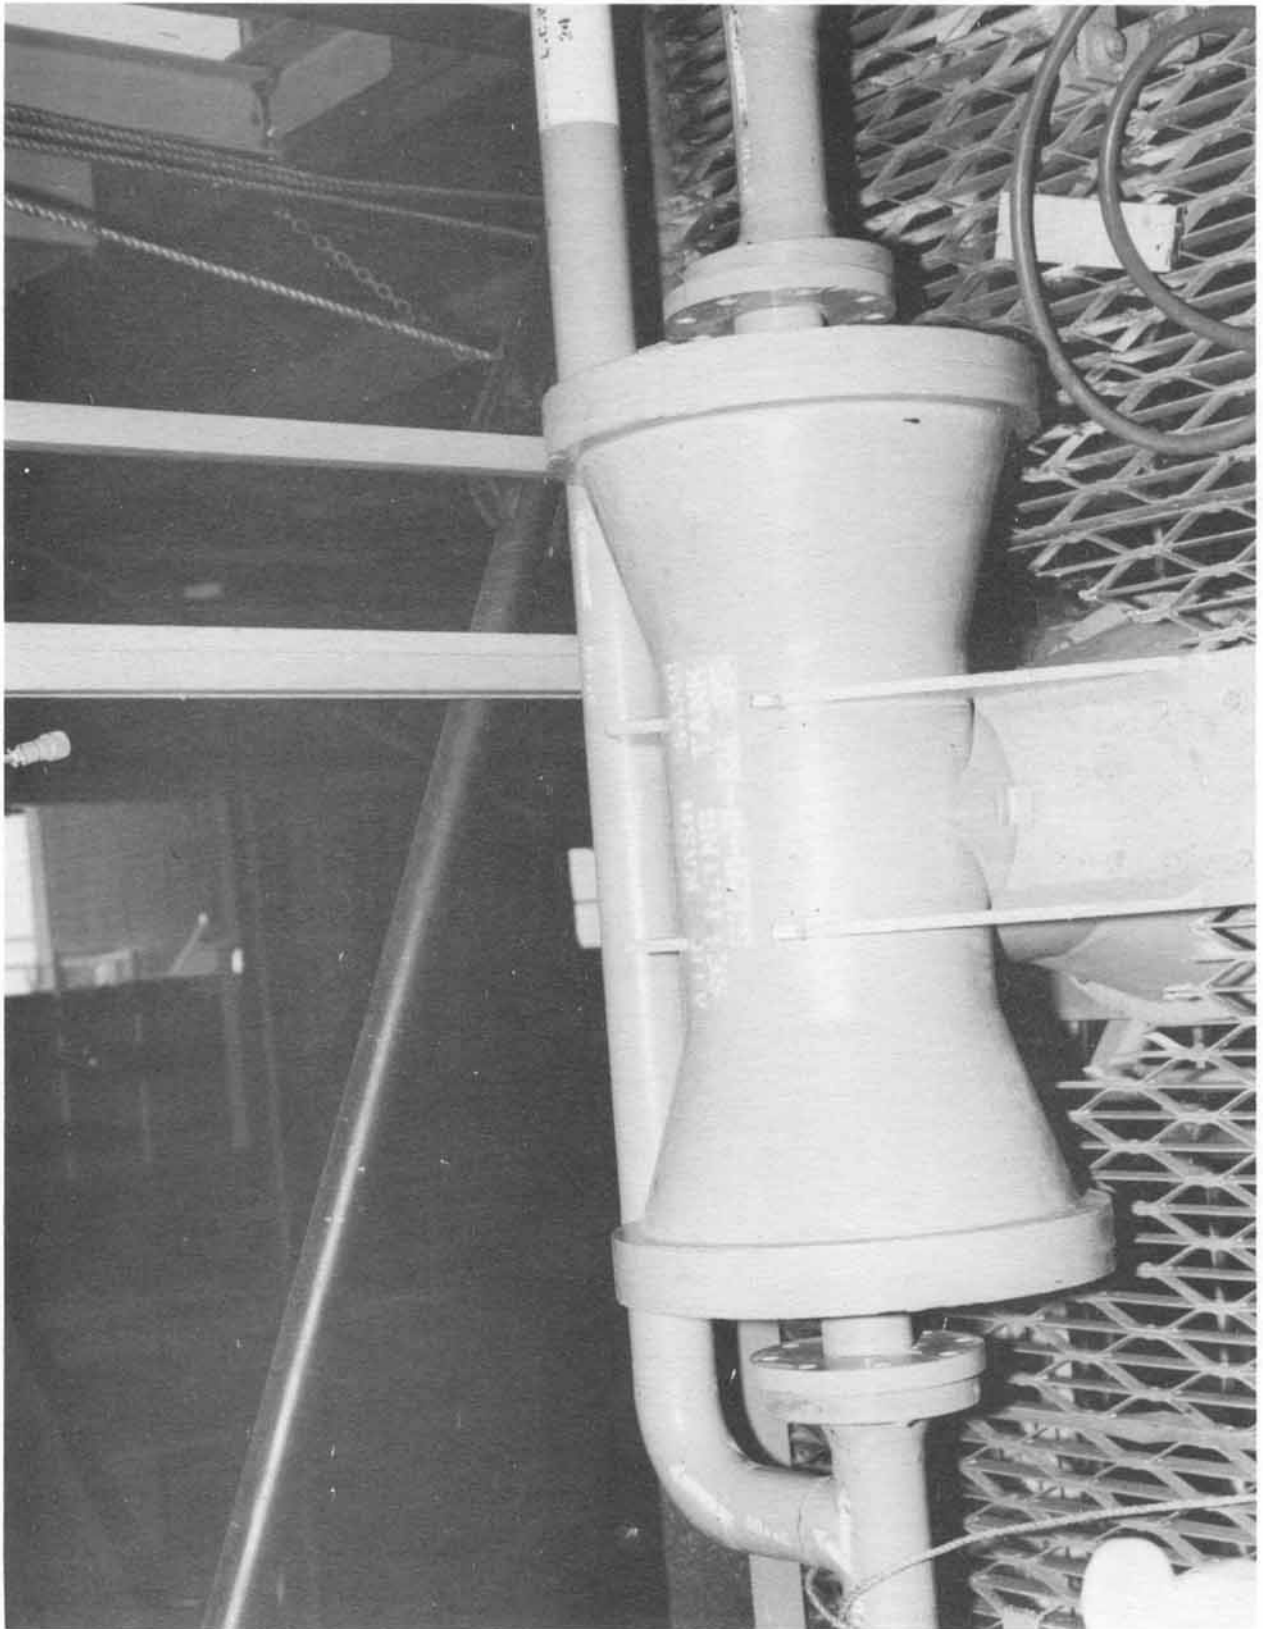
Chilled water and makeup tanks, Q-3, looking toward missile shaftway (Neg. No. 67554A dated 4-19-61).

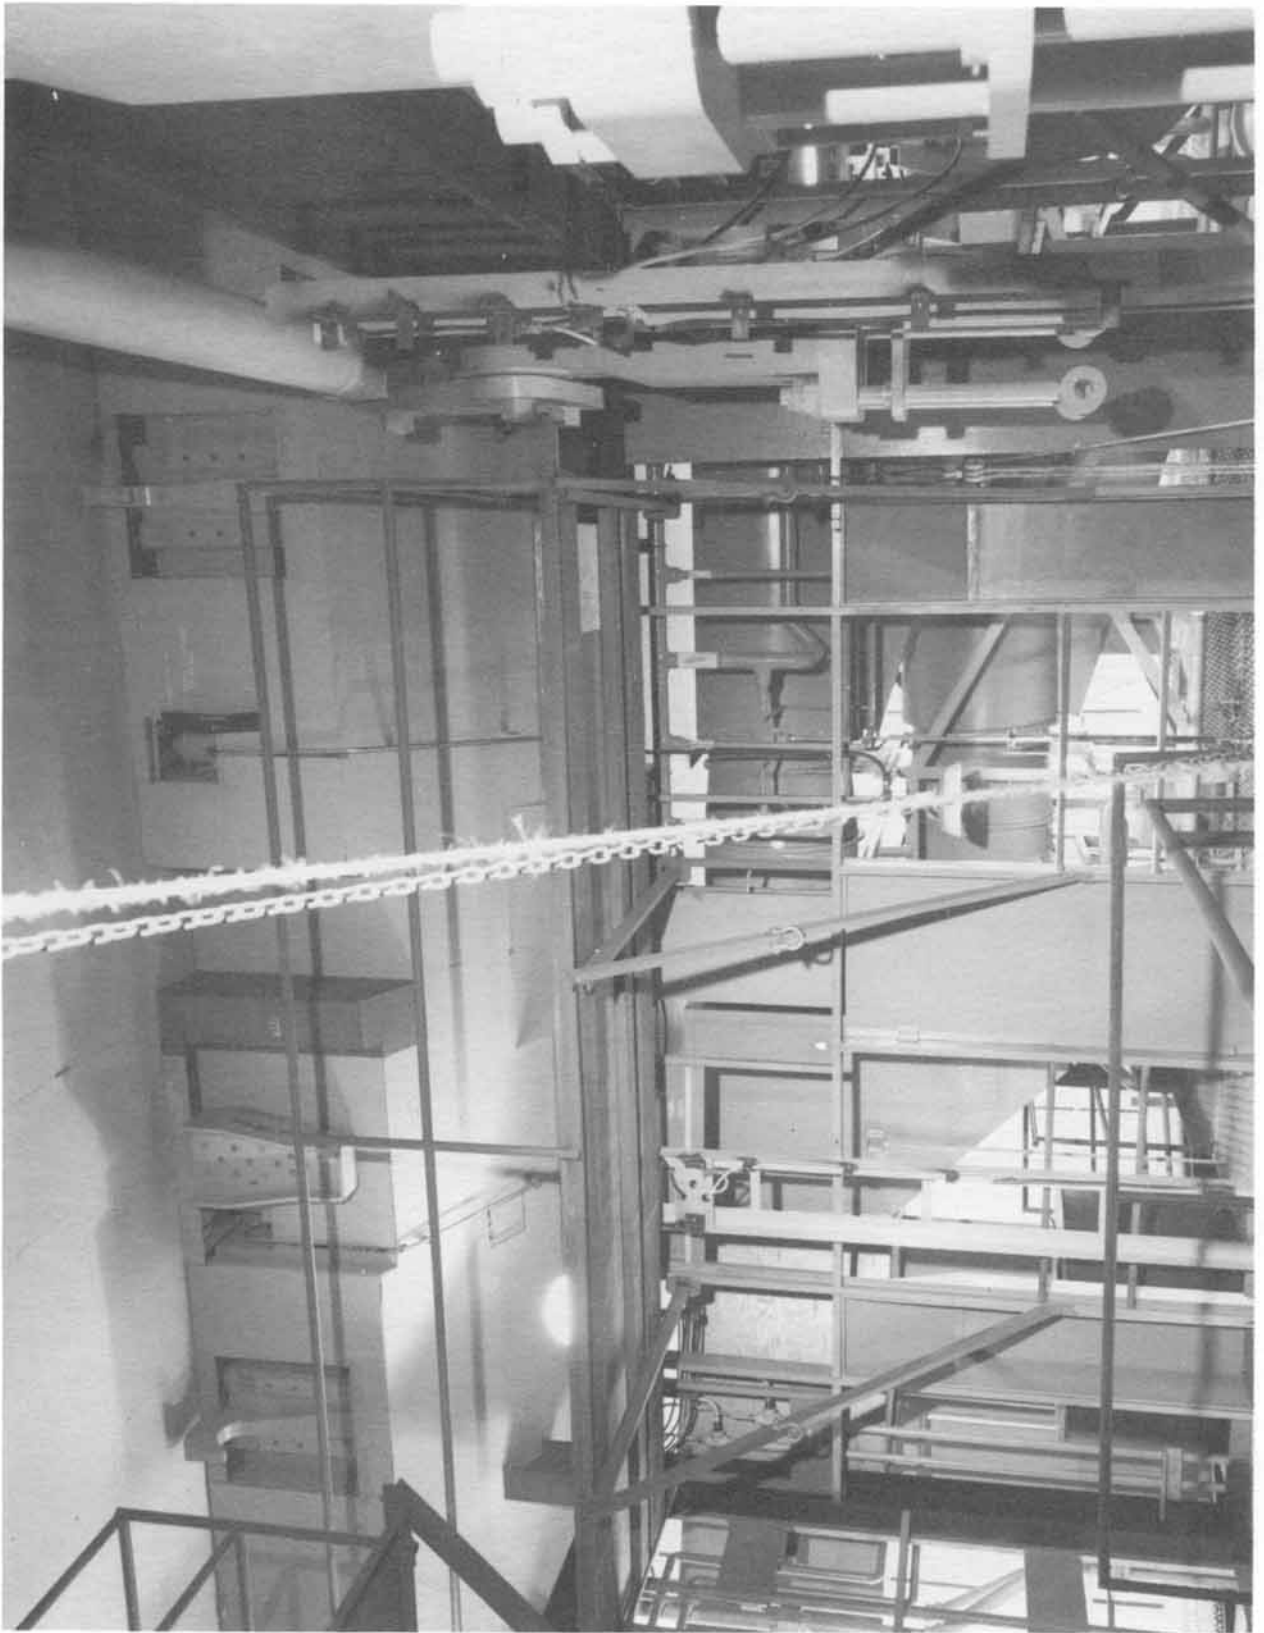
This photo shows close tolerances of Column K penthouse steel. Density of facility and AGE hydraulic system at southwest corner of enclosure (Neg. No. 67556A dated 4-19-61).

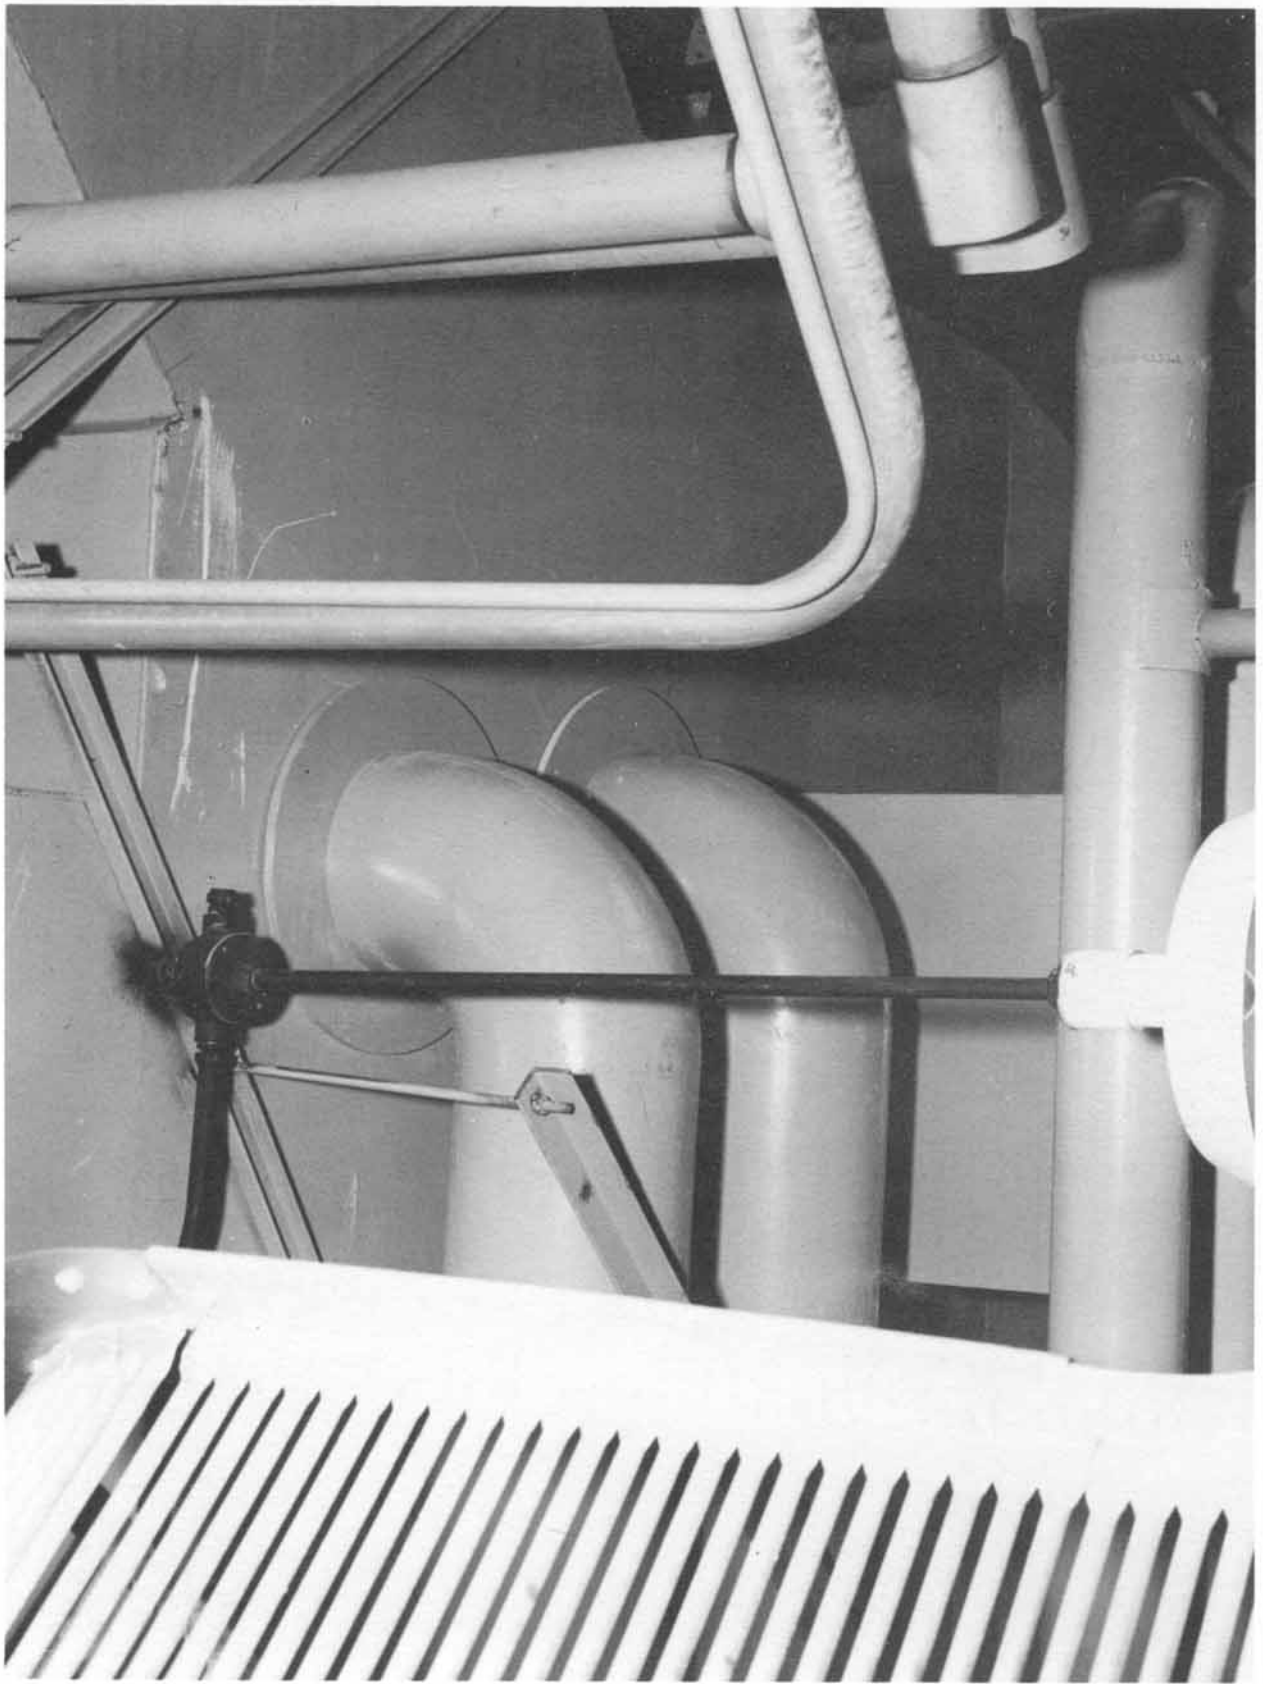
Diesel exhaust on Level 2 (Neg. No. 55752A dated 9-26-60).

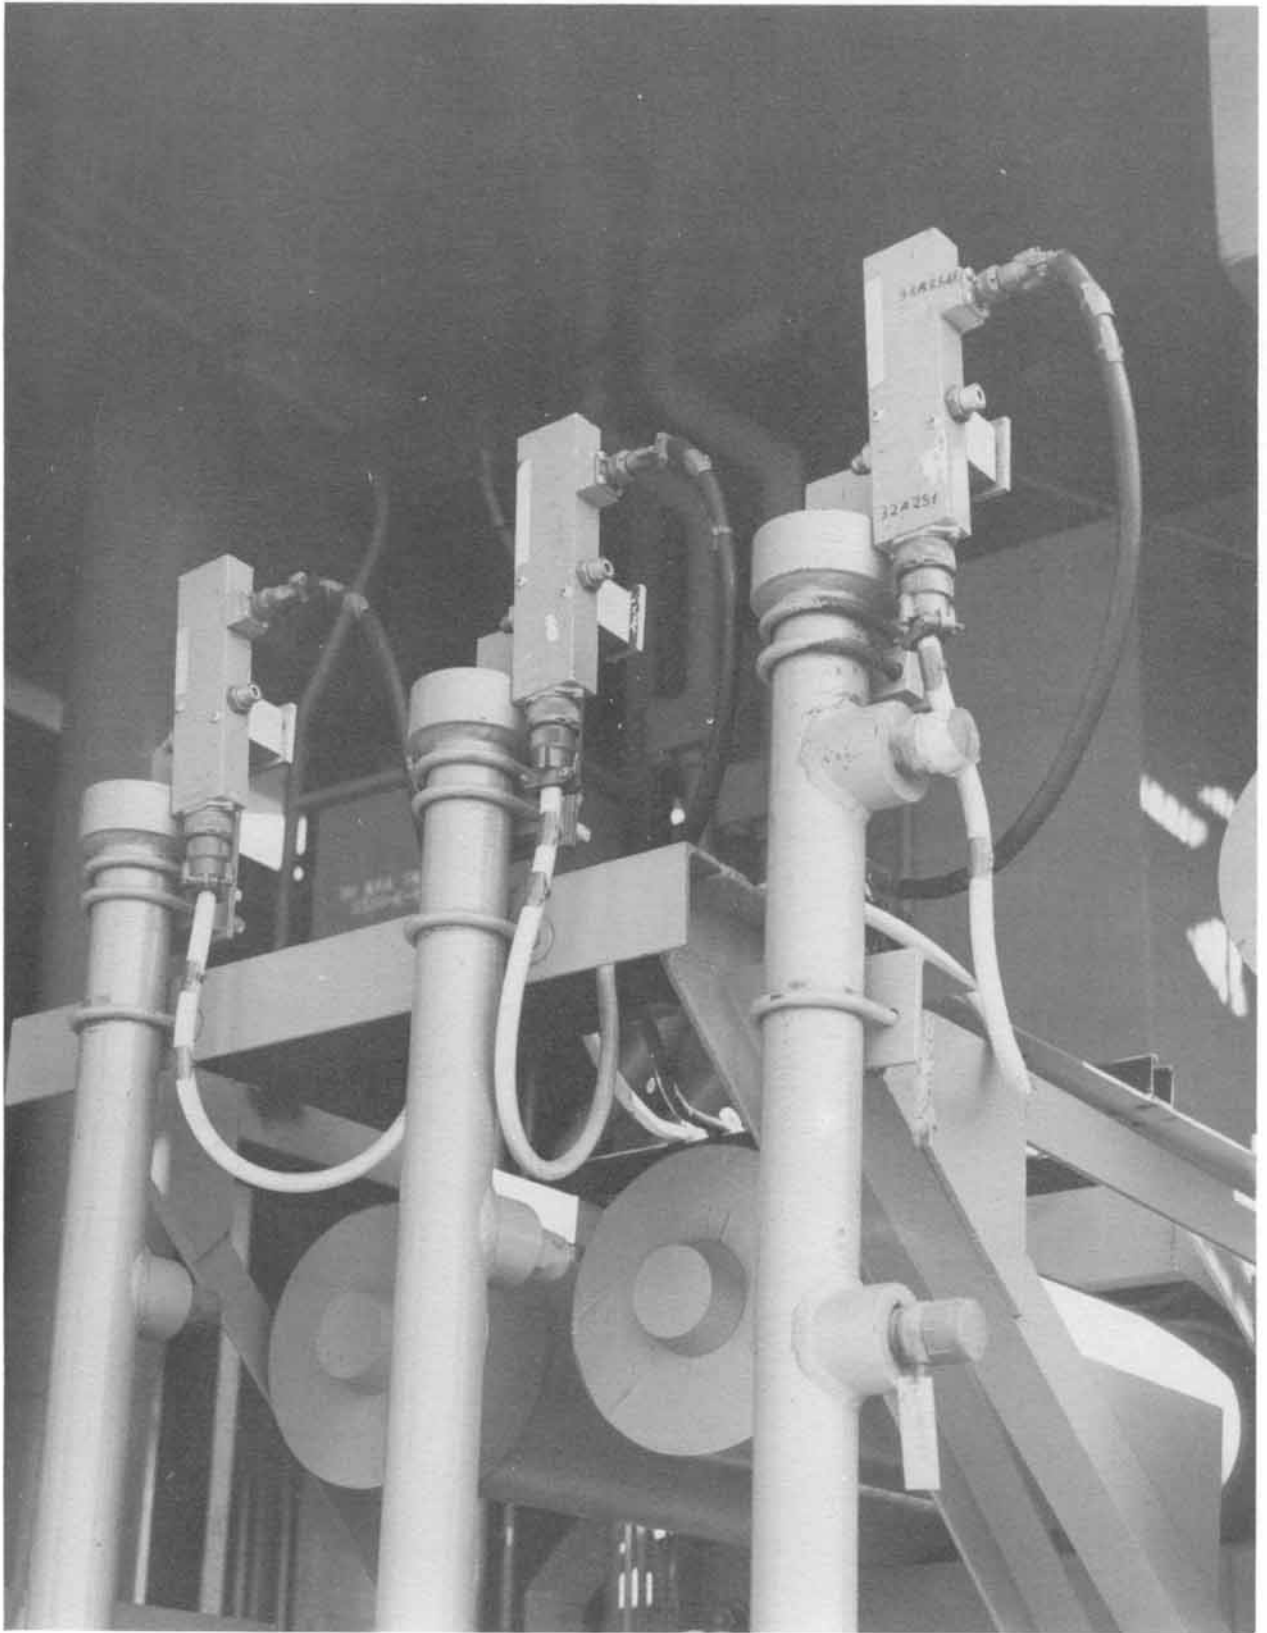
Upper hydraulic power pack valves (Neg. No. 55764A dated 9-26-60).

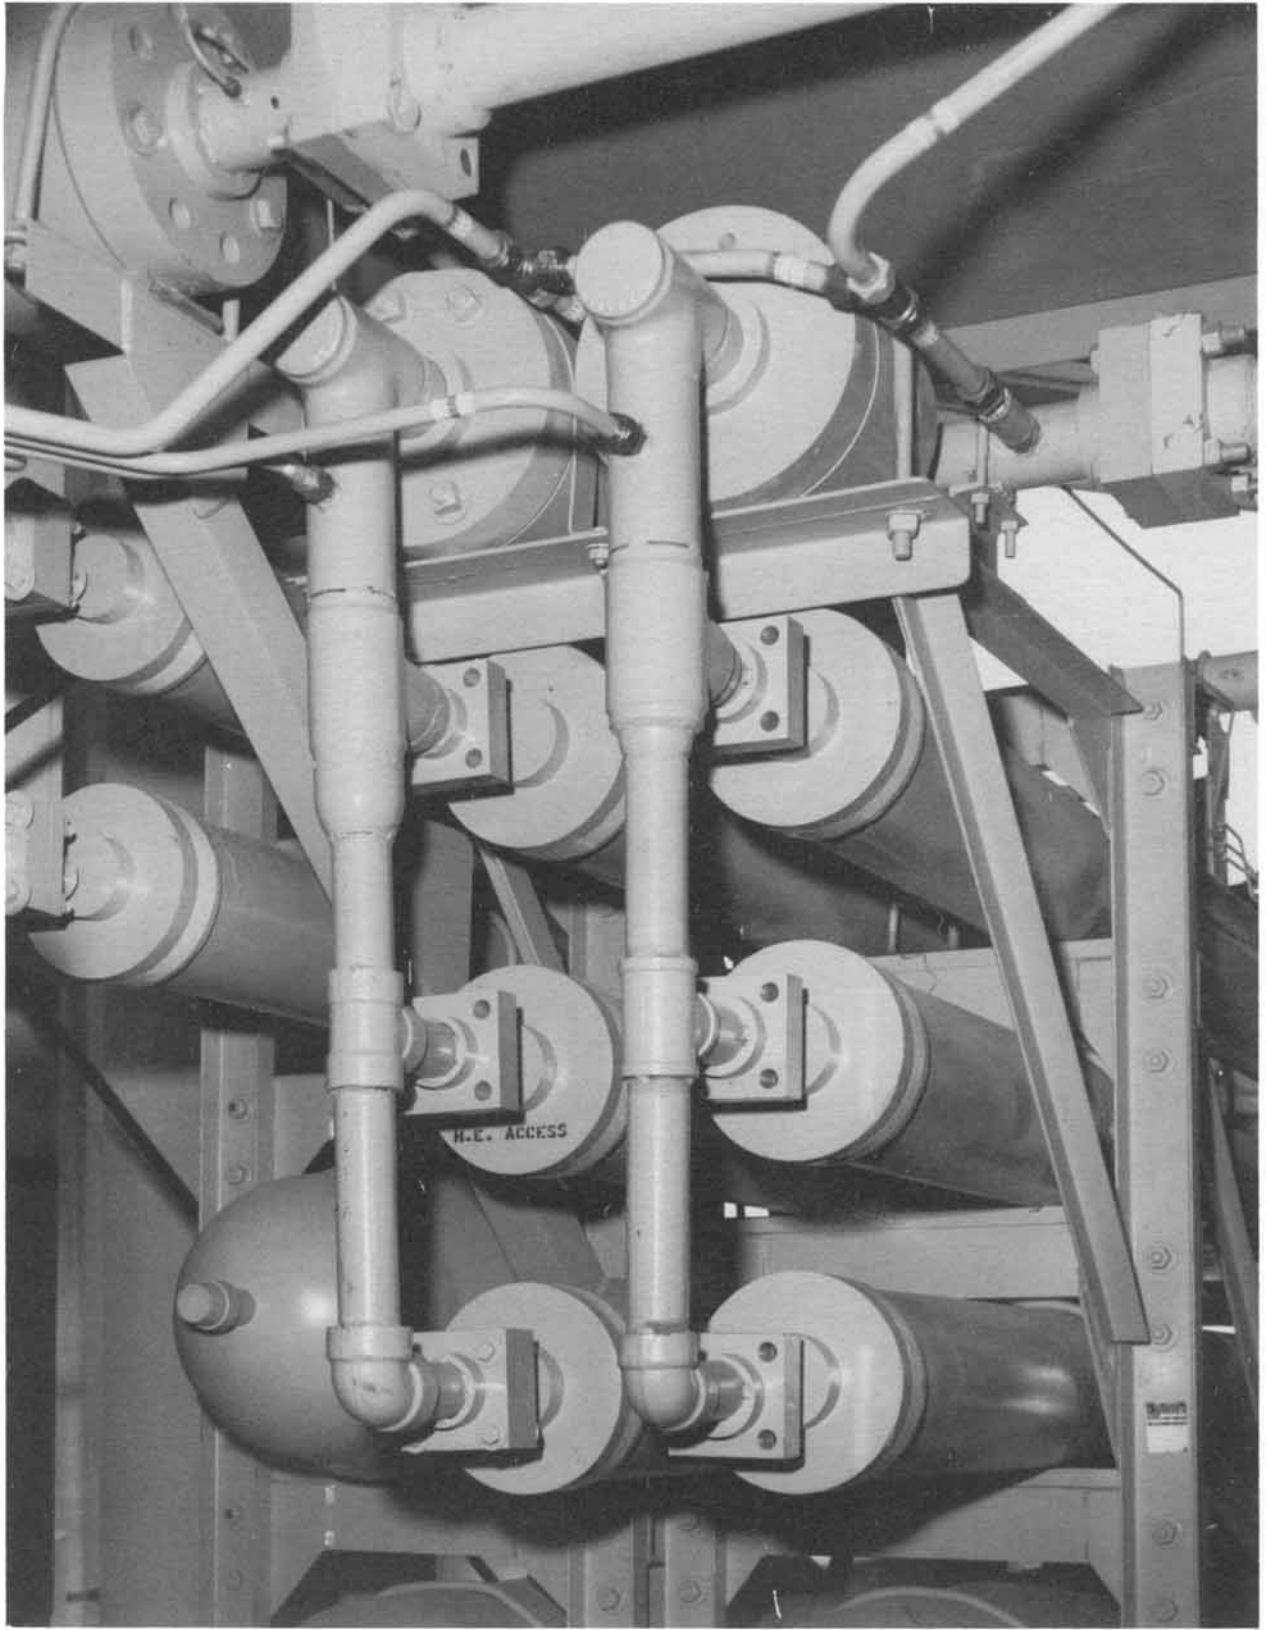
Tubing and piping on power pack (Neg. No. 58766A dated 11-15-60).
