WS 107A-1 WEAPON SYSTEM

SILO FULL-SCALE MOCKUP

PHOTOGRAPH RECORD

15 May 1961

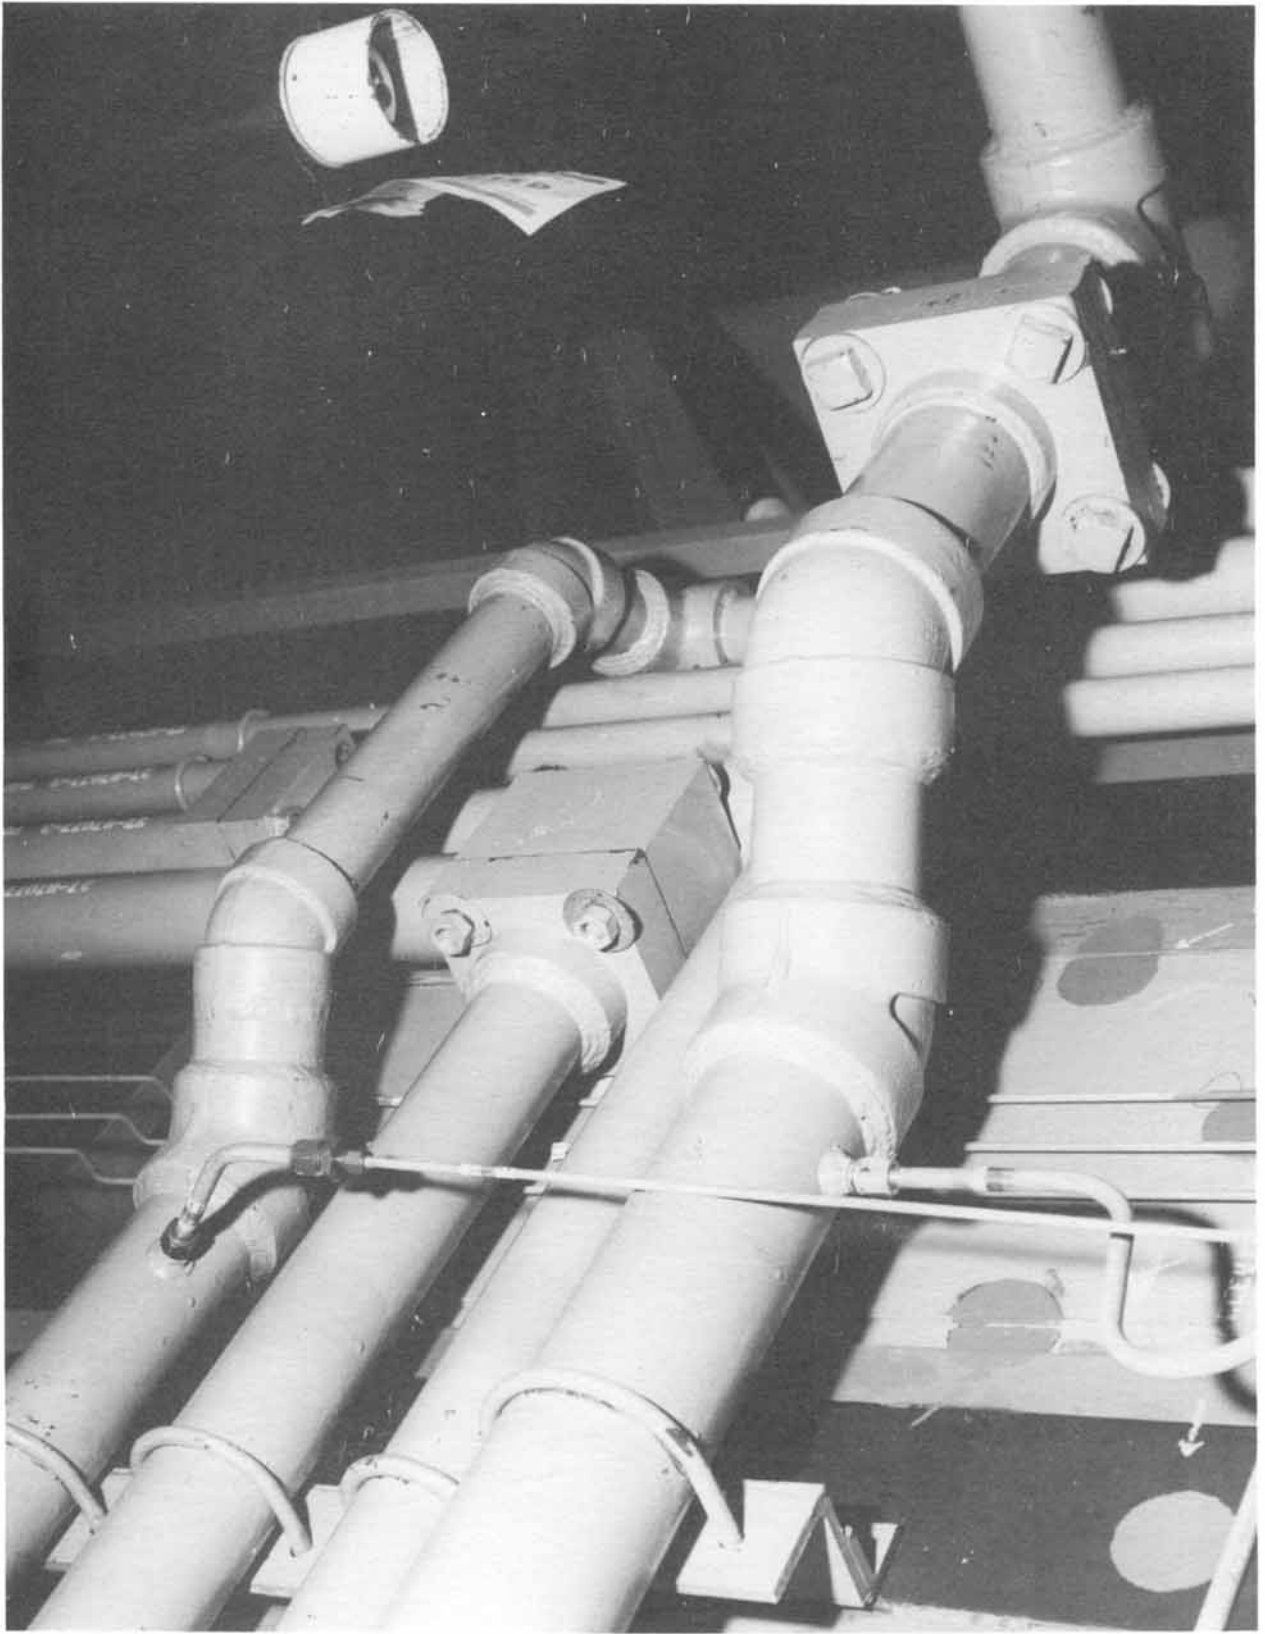
View of interconnects and routing of hydraulic pipes leaving the manifolds (Neg. No. 67559A dated 4-19-61).

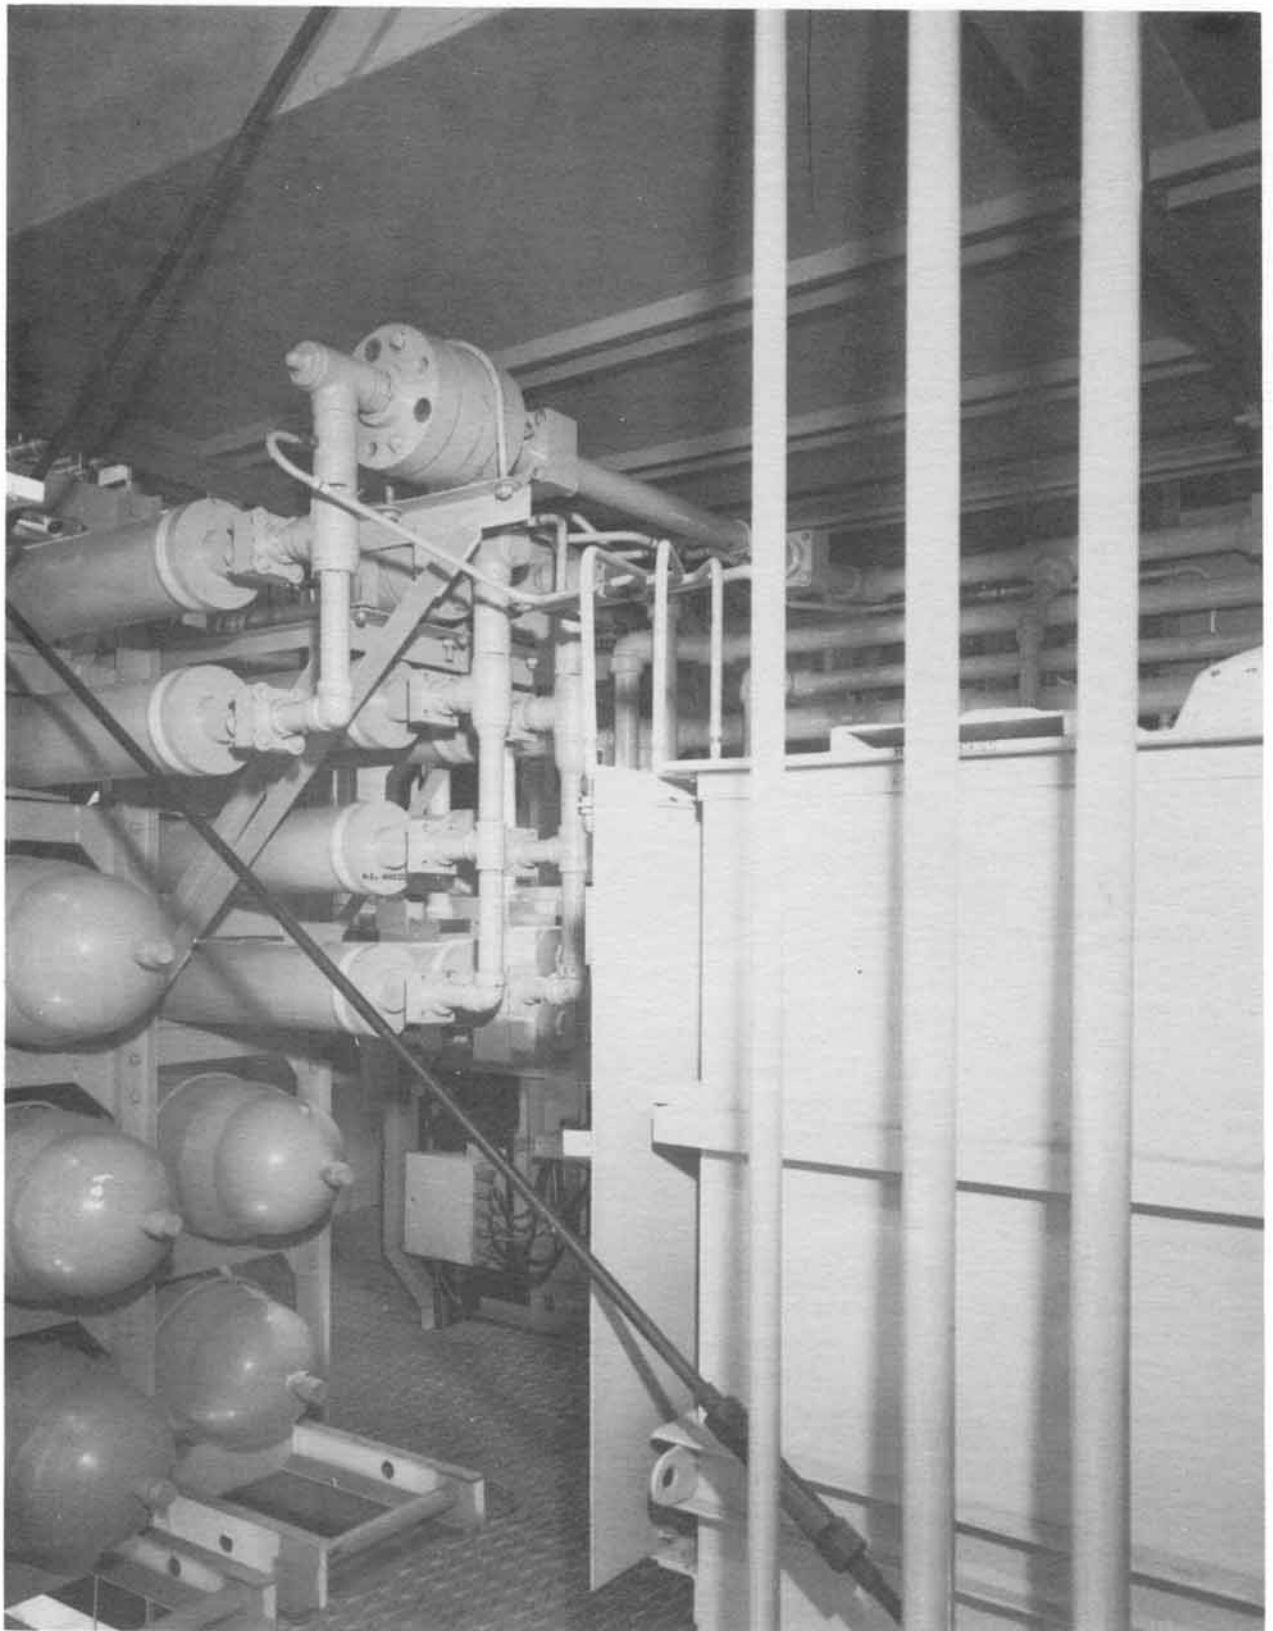
Hydraulic accumulators viewed from the south side (Neg. No. 68026A dated 4-26-61).

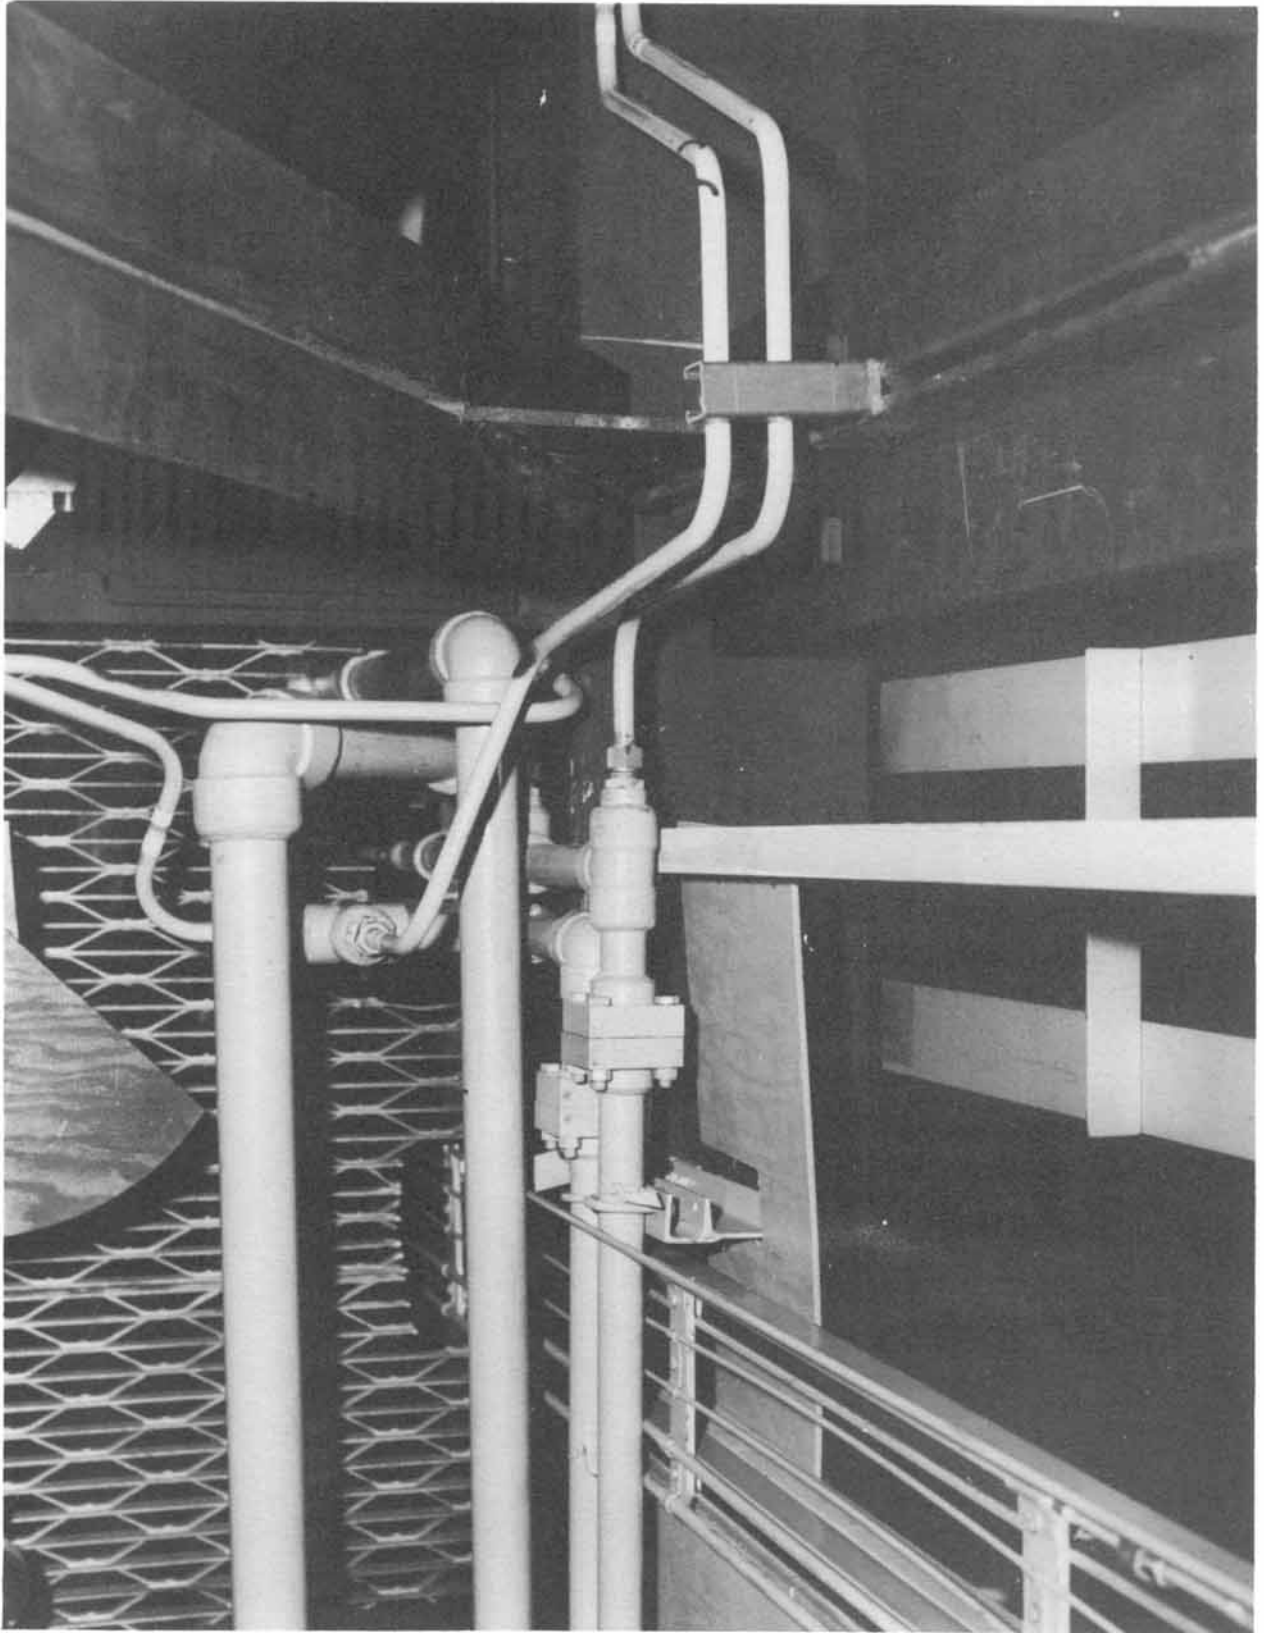
View showing congestion where hydraulic lines turn west under Level 4  
(Neg. No. 67565A dated 4-19-61).

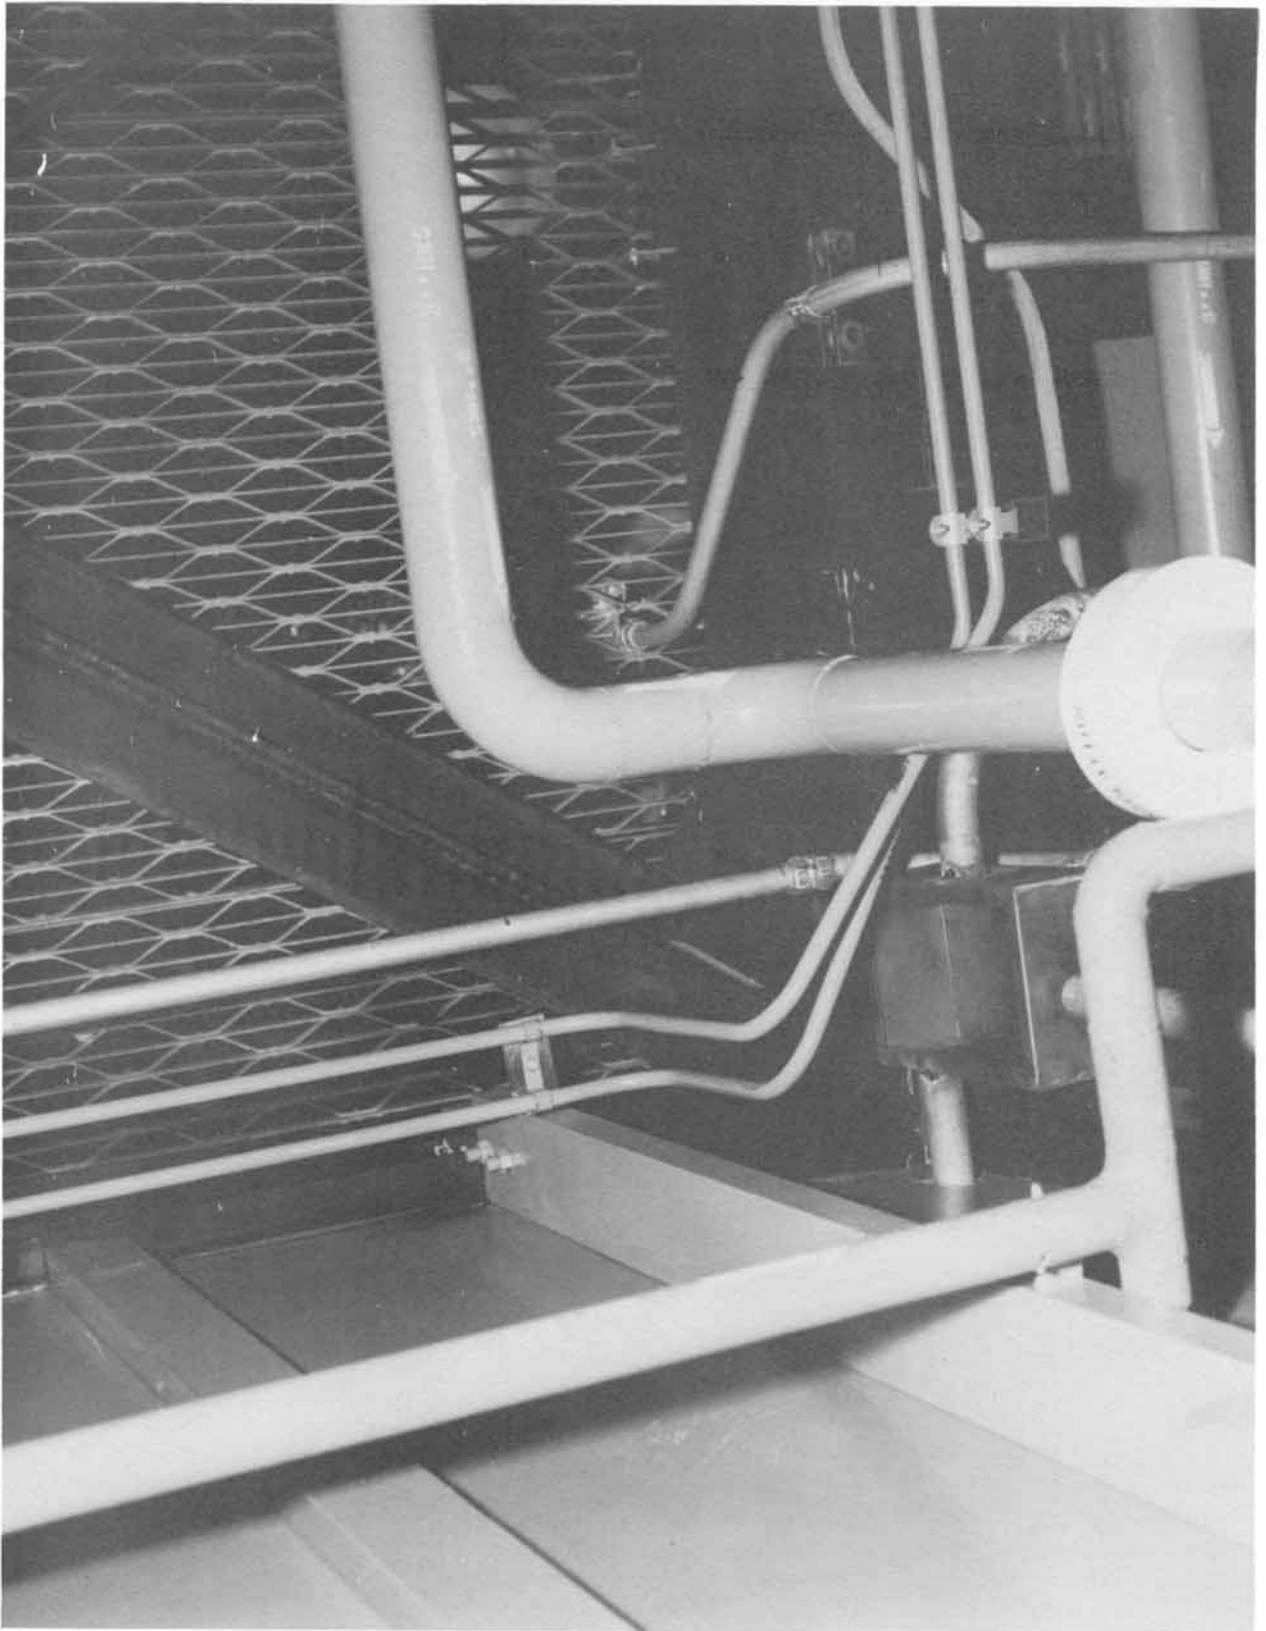
Showing north vertical lock lines as they should be routed--Column J  
(Neg. No. 67567A dated 4-19-61).

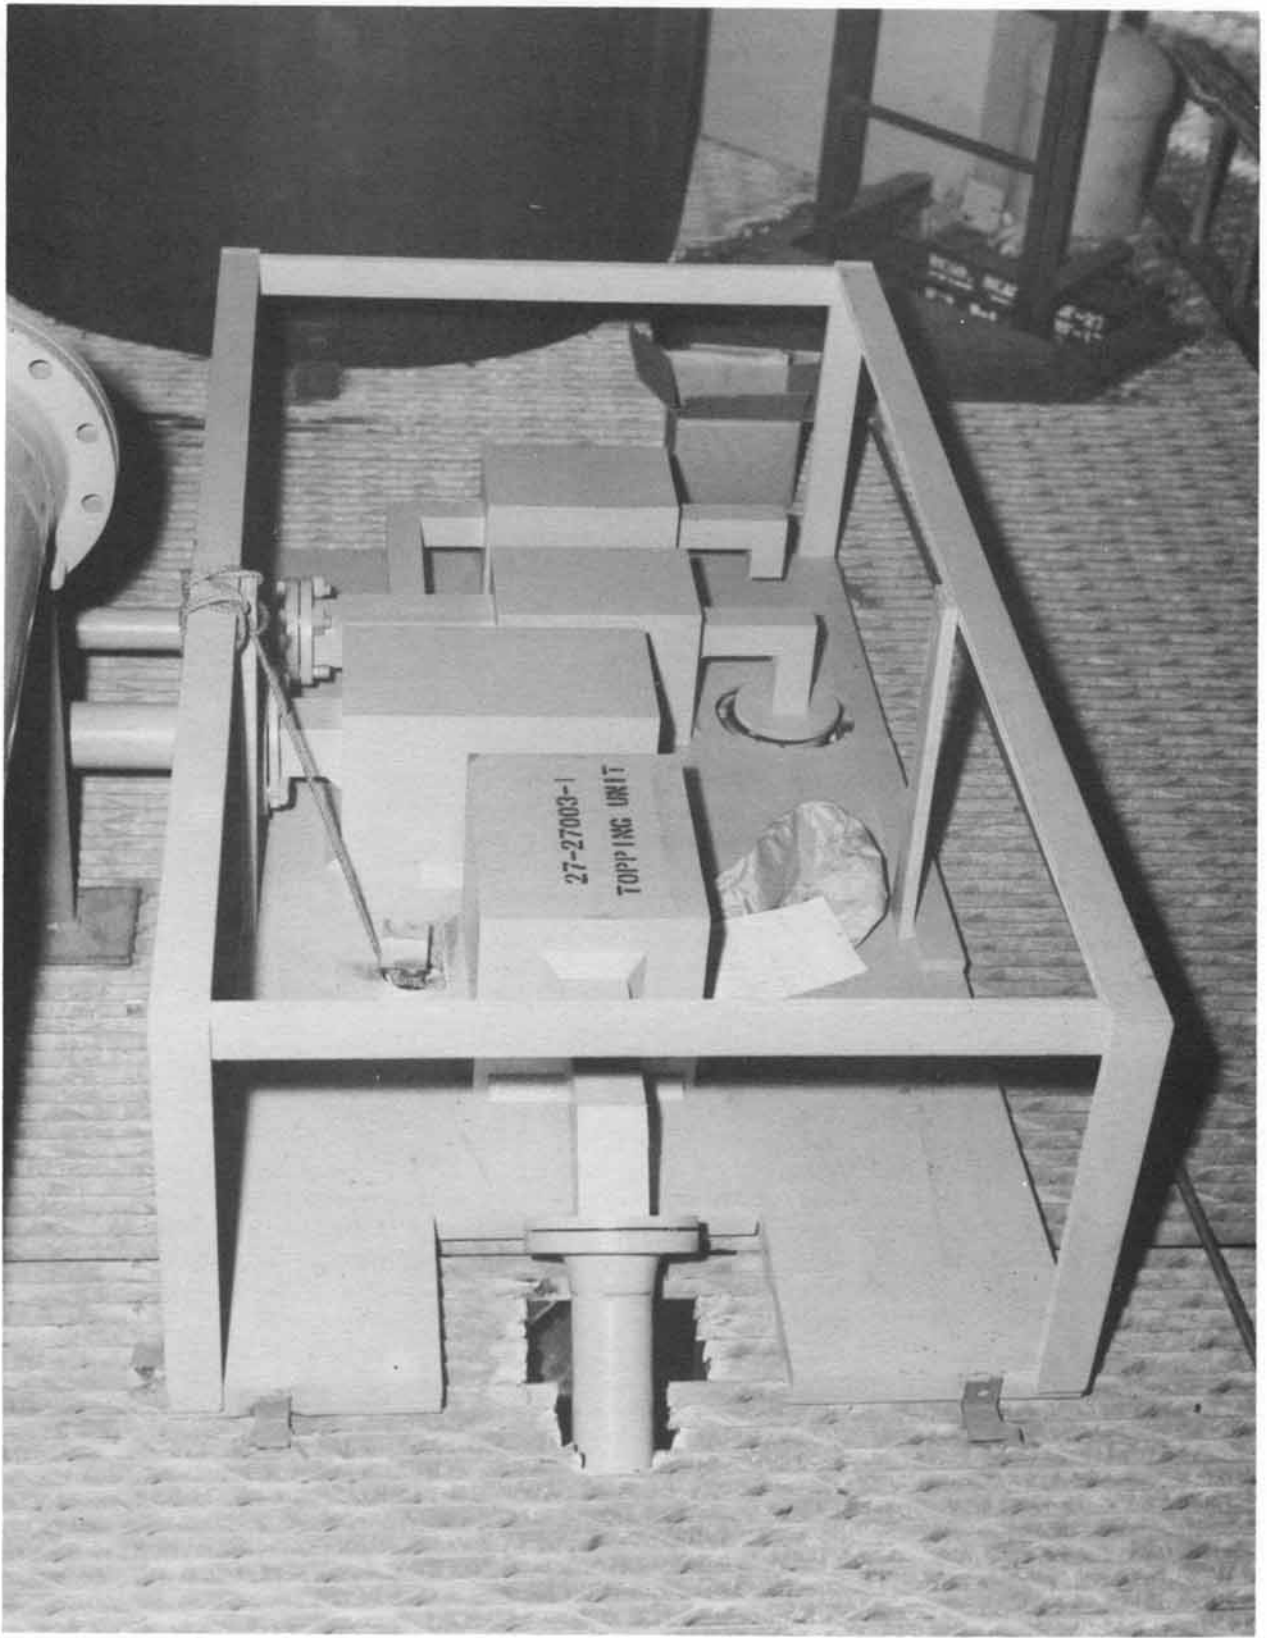
LO<sub>2</sub> topping unit (Neg. No. 67362A dated 4-14-61).

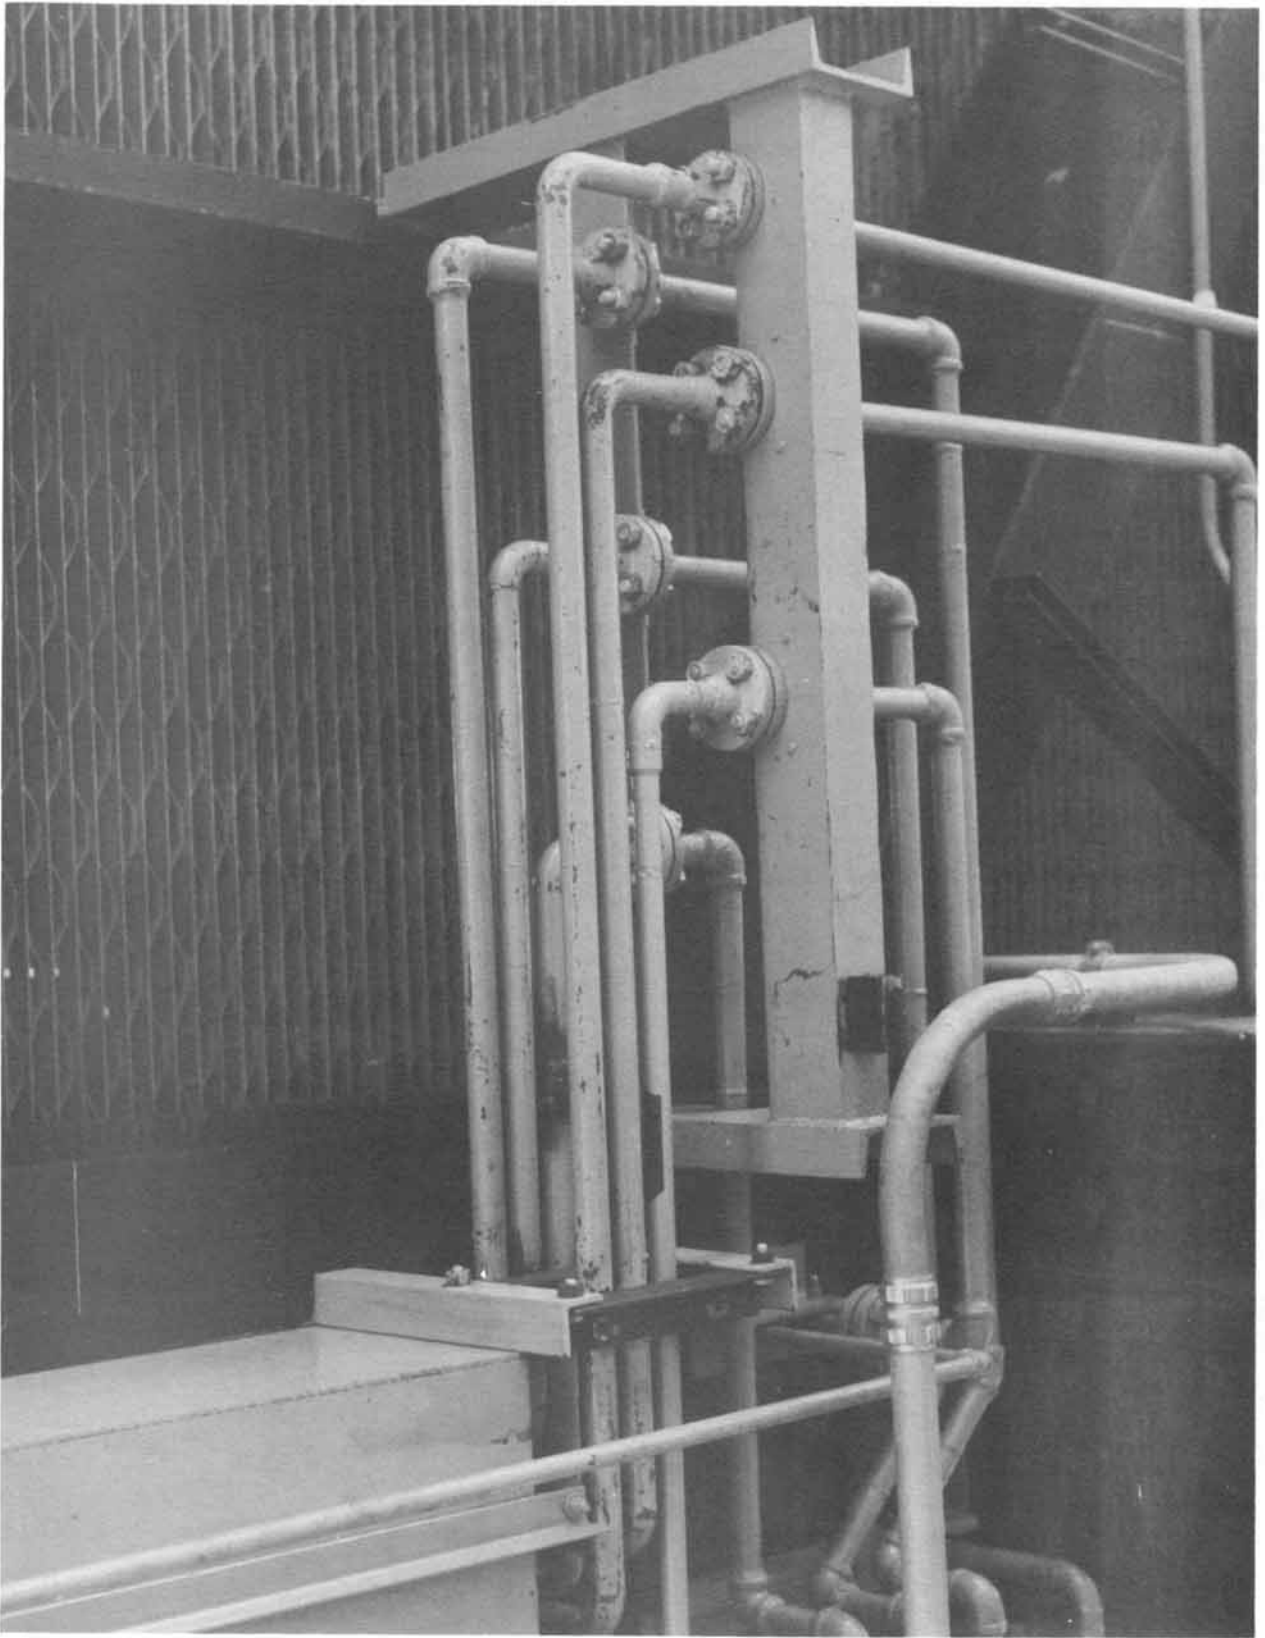
Pressurization control unit facility interface at Column J below Level 8  
(Neg. No. 67365A dated 4-14-61).

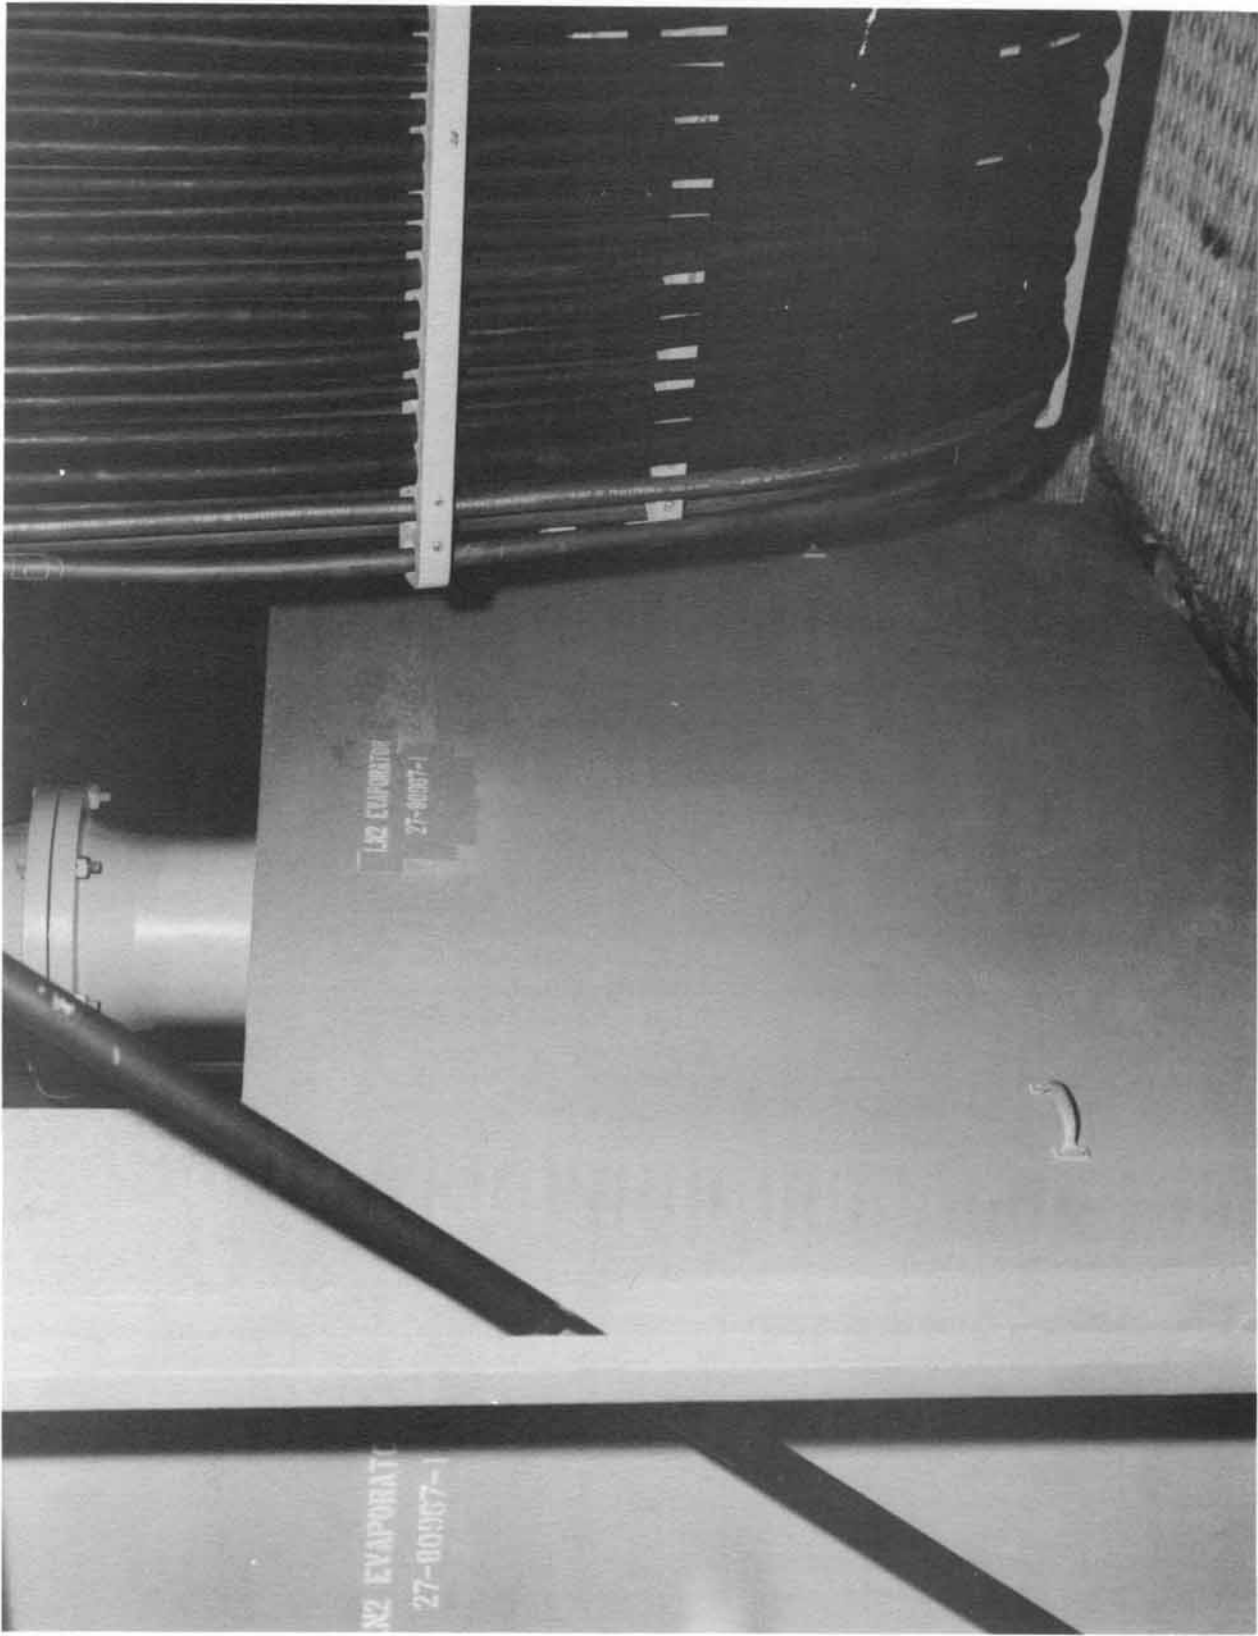
View of Quad 3 side of LN<sub>2</sub> evaporator tank (Neg. No. 67568A dated 4-19-61).
